# SOCORRO INTERCEPTING DRAIN

CONDITION PROFILE 1960.

23-503-6159

SOCORRO and RIO  
INTERCEPTING DRAINS  
CONDITION PROFILE 1960.  
23-503-6159

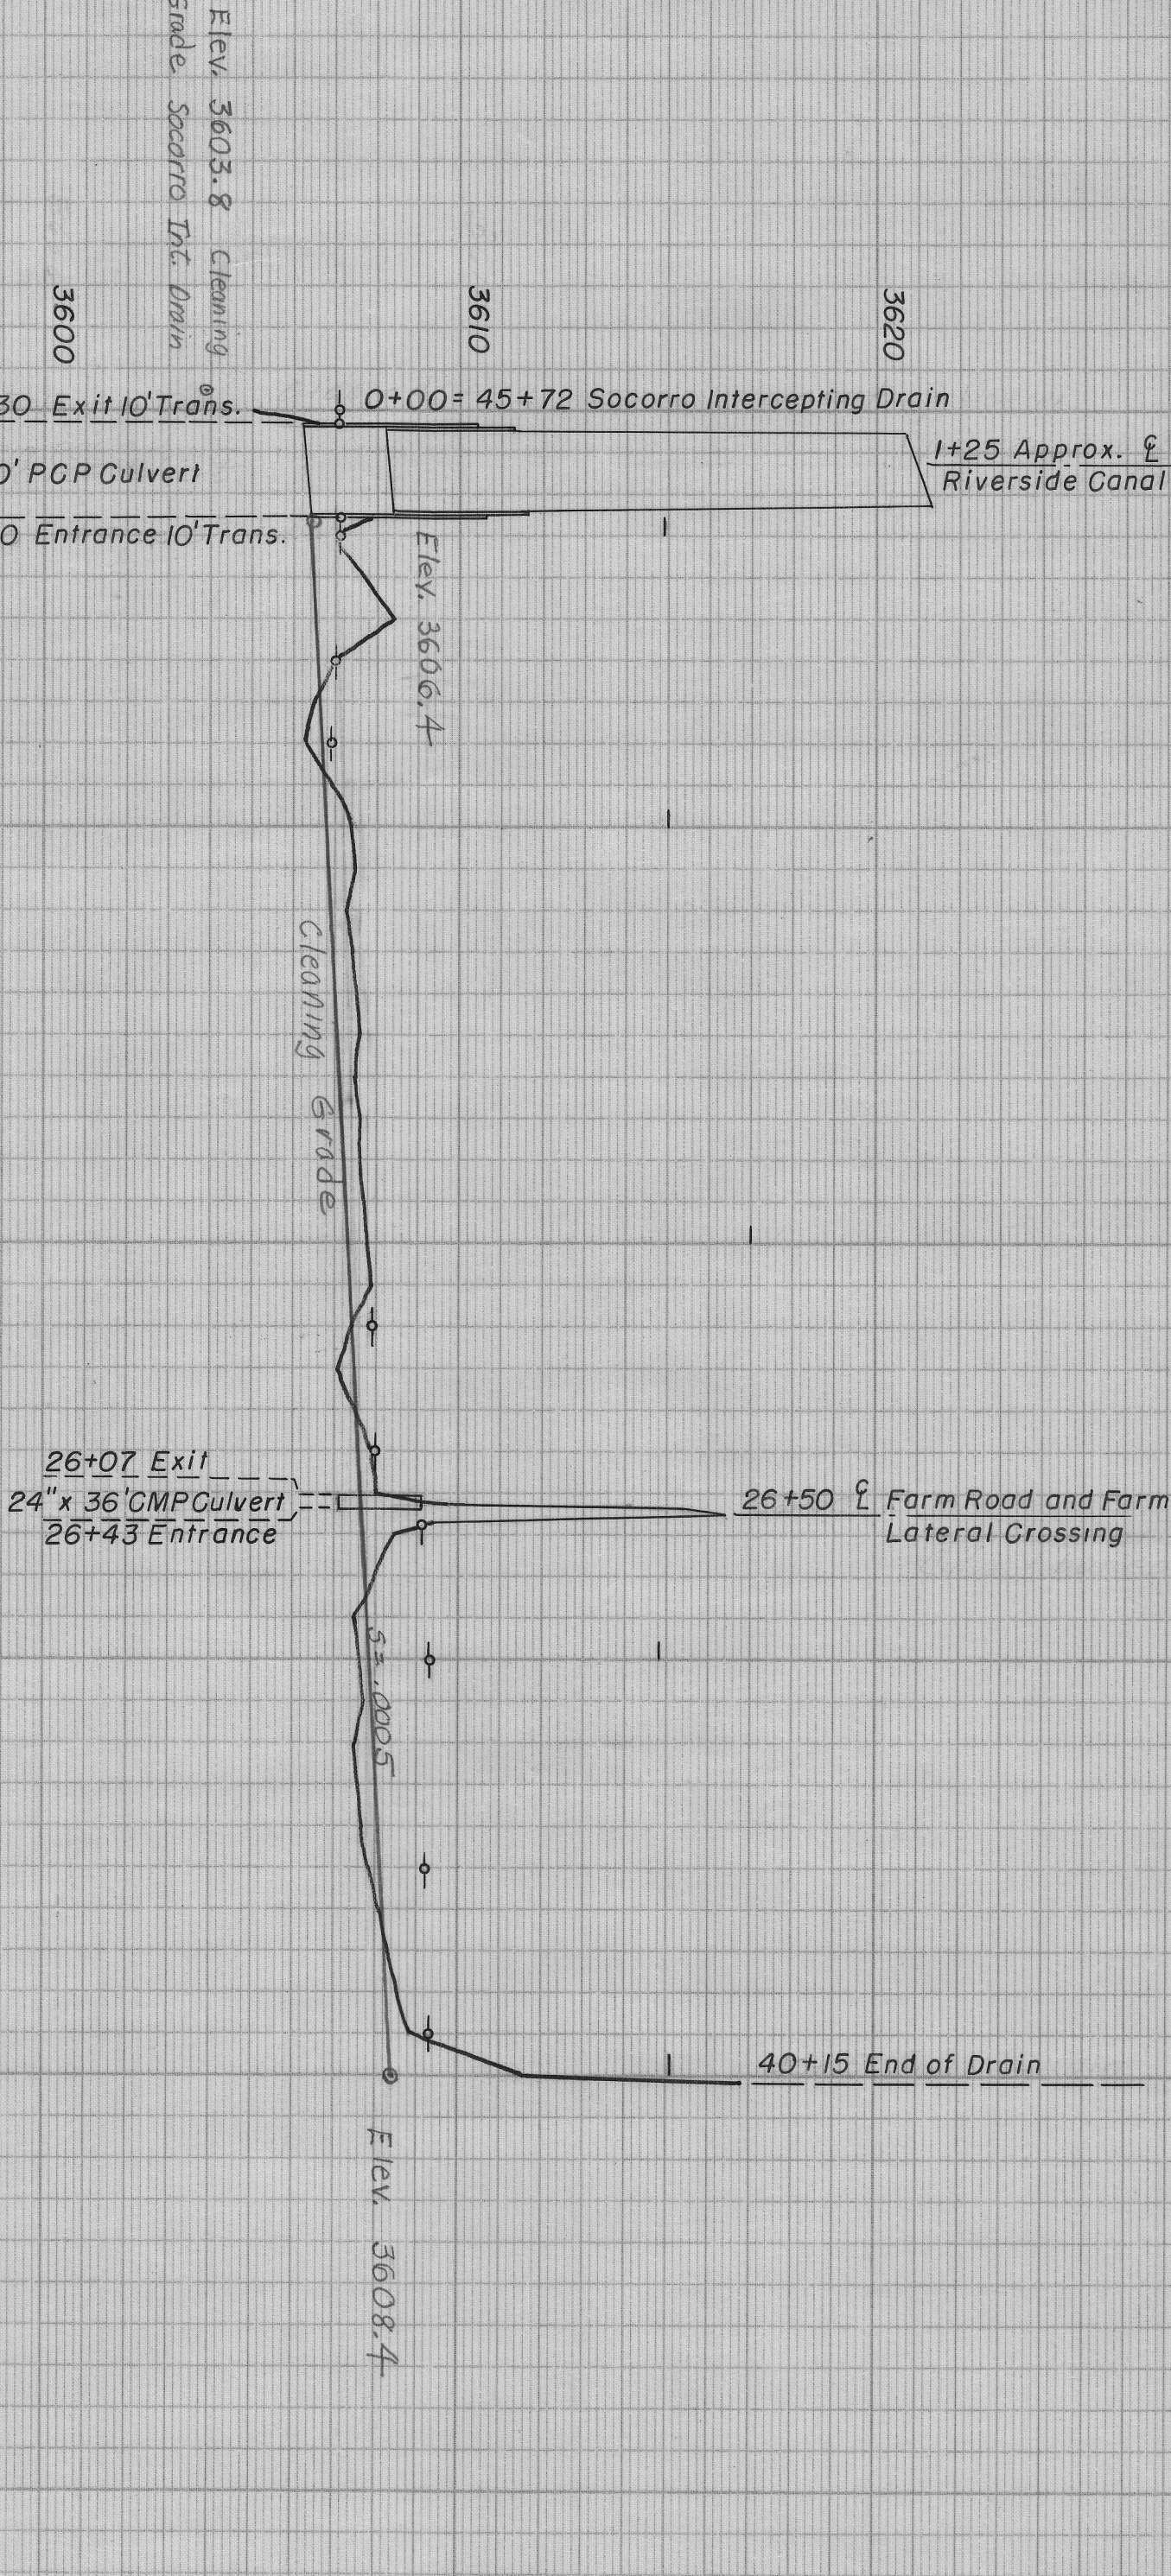
# RIO INTERCEPTING DRAIN

CONDITION PROFILE 1960.

Note: Clean to indicated cleaning grade.
