# RODRIGUEÑA LATERAL CONDITION PROFILE 1960

Surveyed by Taylor Aug. 1960.  
Nov. 1960

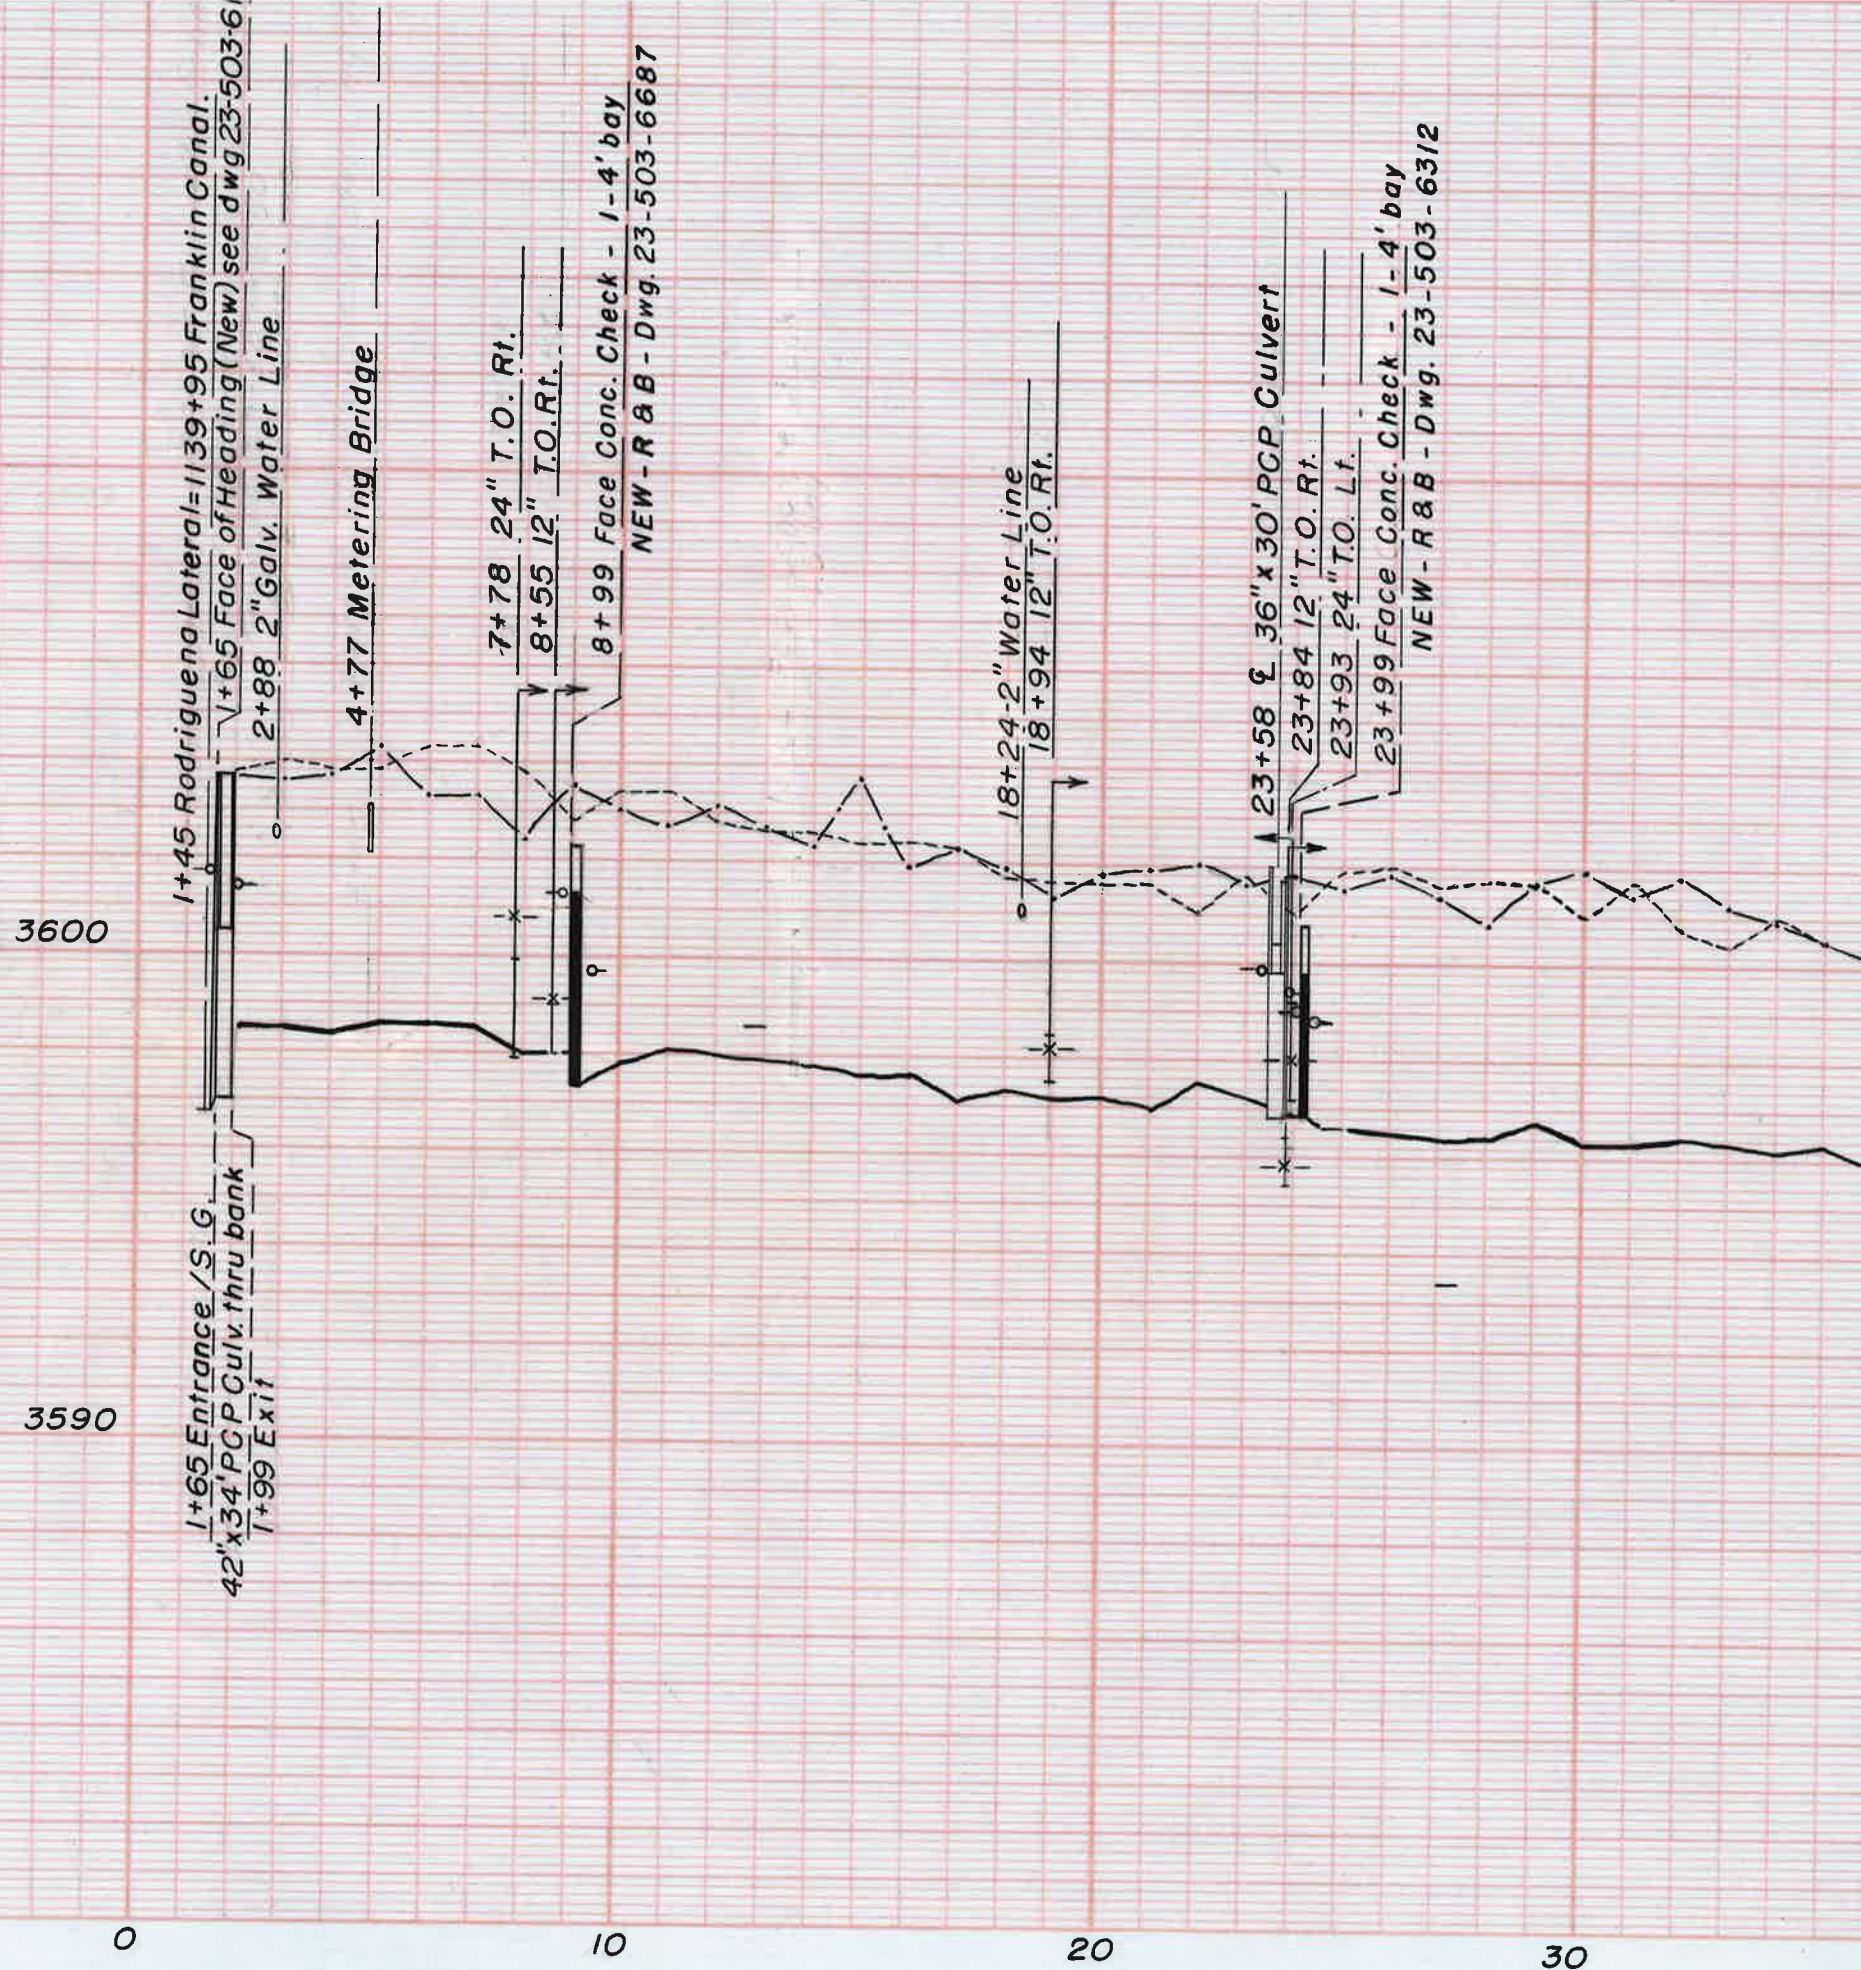
23-503-6282

B.M. for this profile was destroyed when Clint Lateral Heading was rebuilt.
