## **I-154 LATERAL** CONDITION PROFILE 1961

Surveyed by Taylor Mar., 1961  
Notes in Field Book 3172 Ysleta.  
Plotted and Inked by: ERJ 7/5/61.  
Checked by: *R.C.*  
Revised 2-21-63 SP  
To show R & B structures

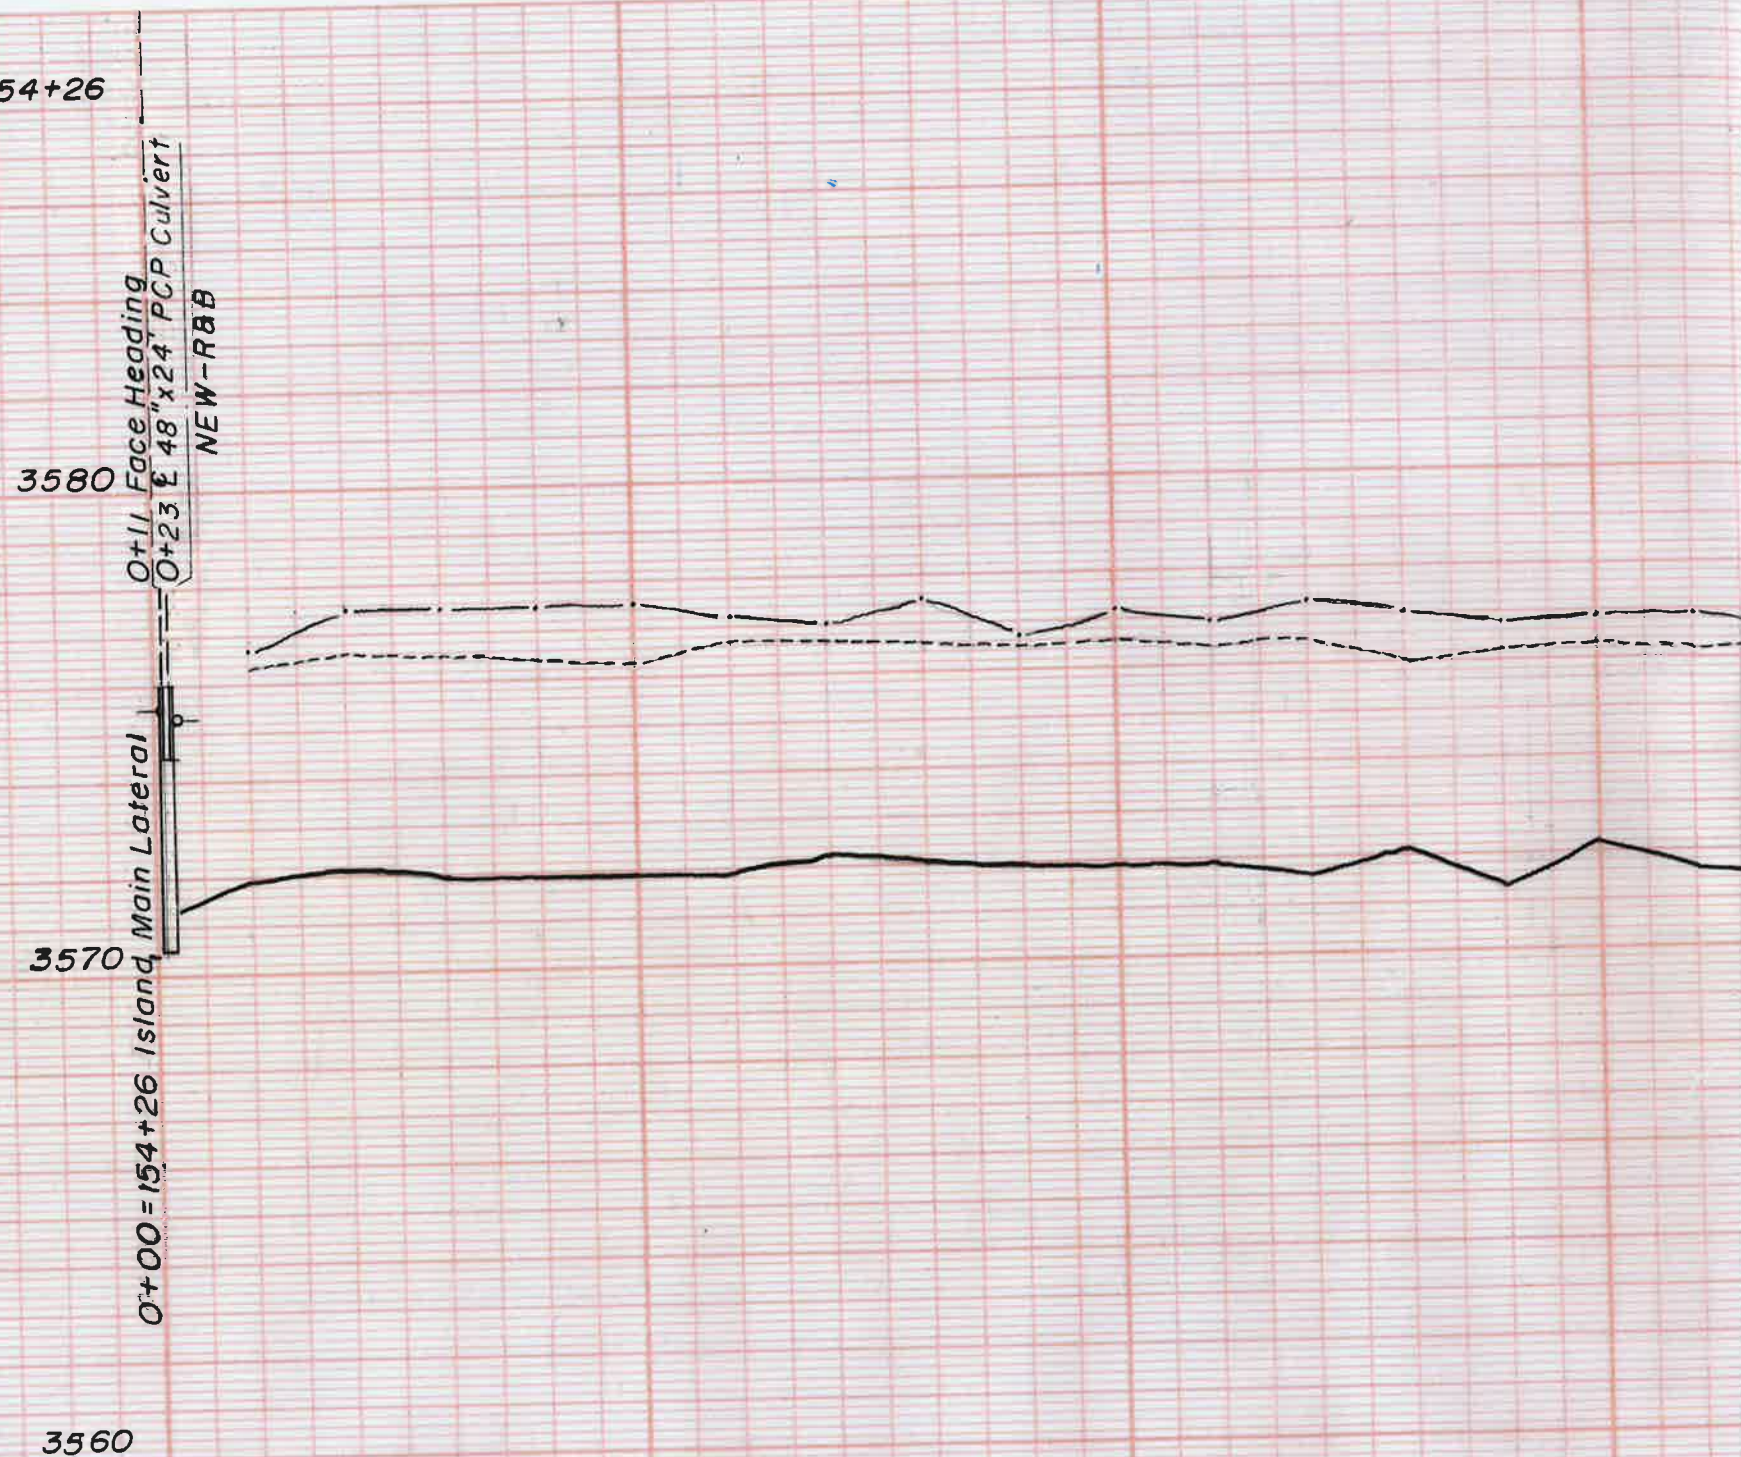
B.M. Elev. 3576.85 "□" On top of concrete below right rail of check at Sta. 154+26  
in Island Main Lateral at I-154 heading.
