## MONTOYA MAIN LATERAL

1959 - 1962 Condition Profile

23-503-6635

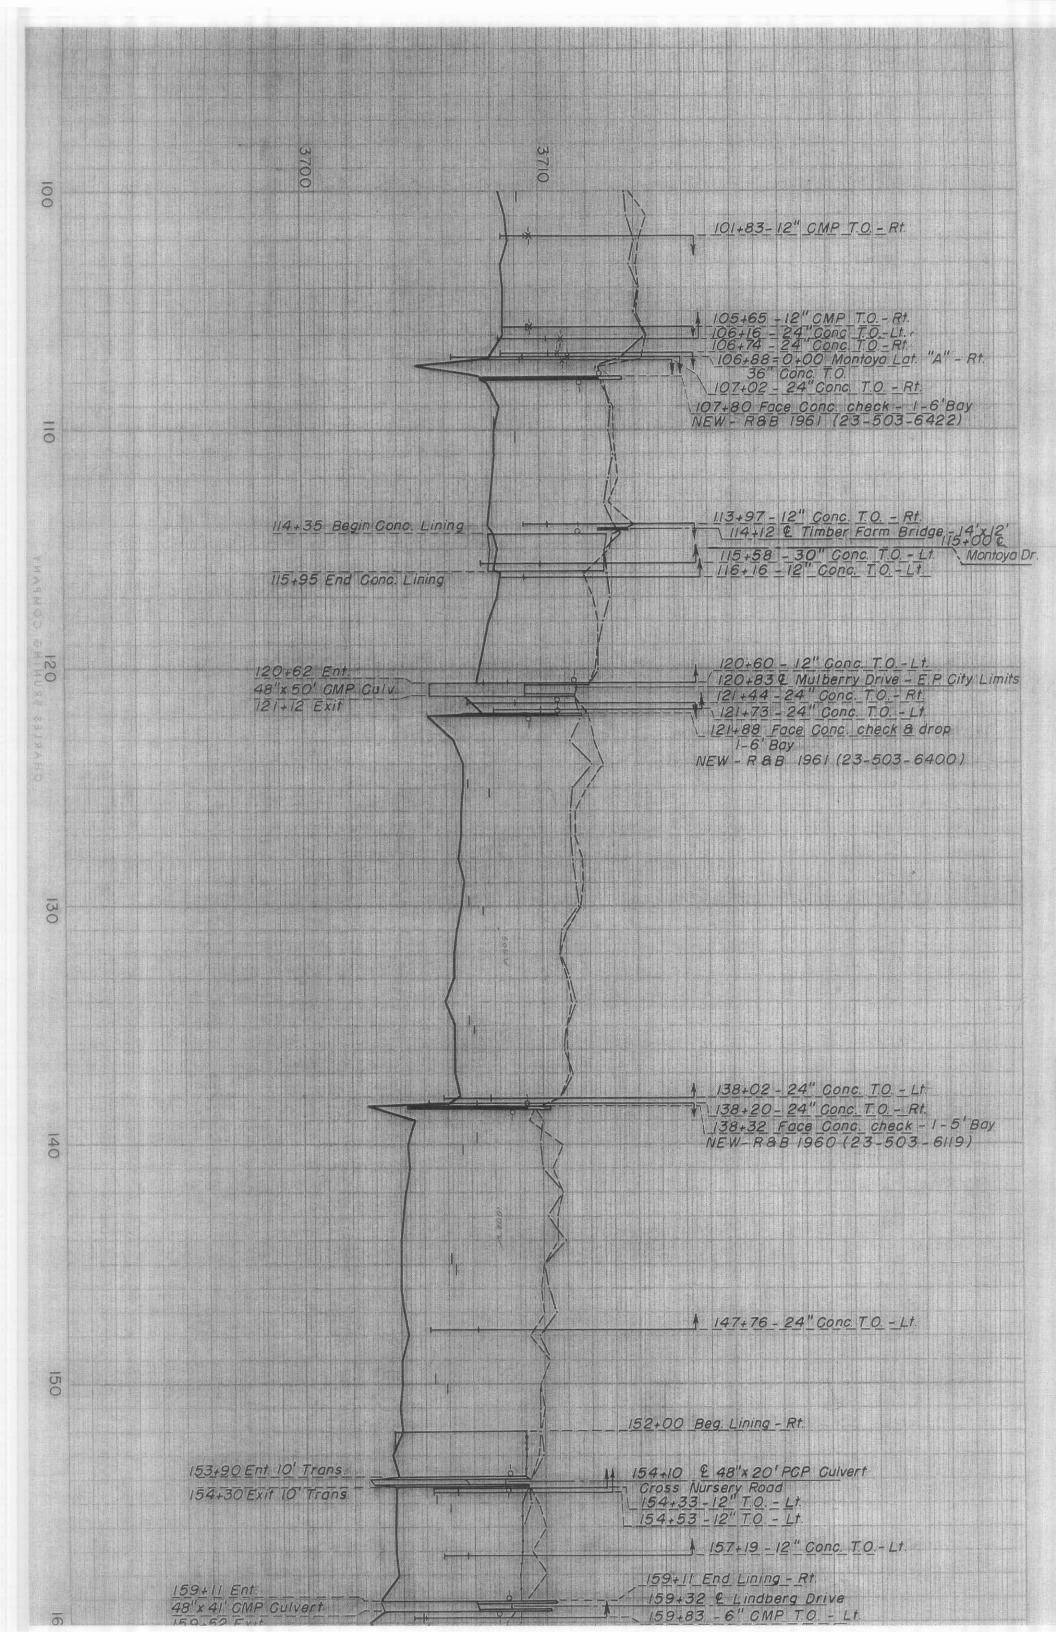
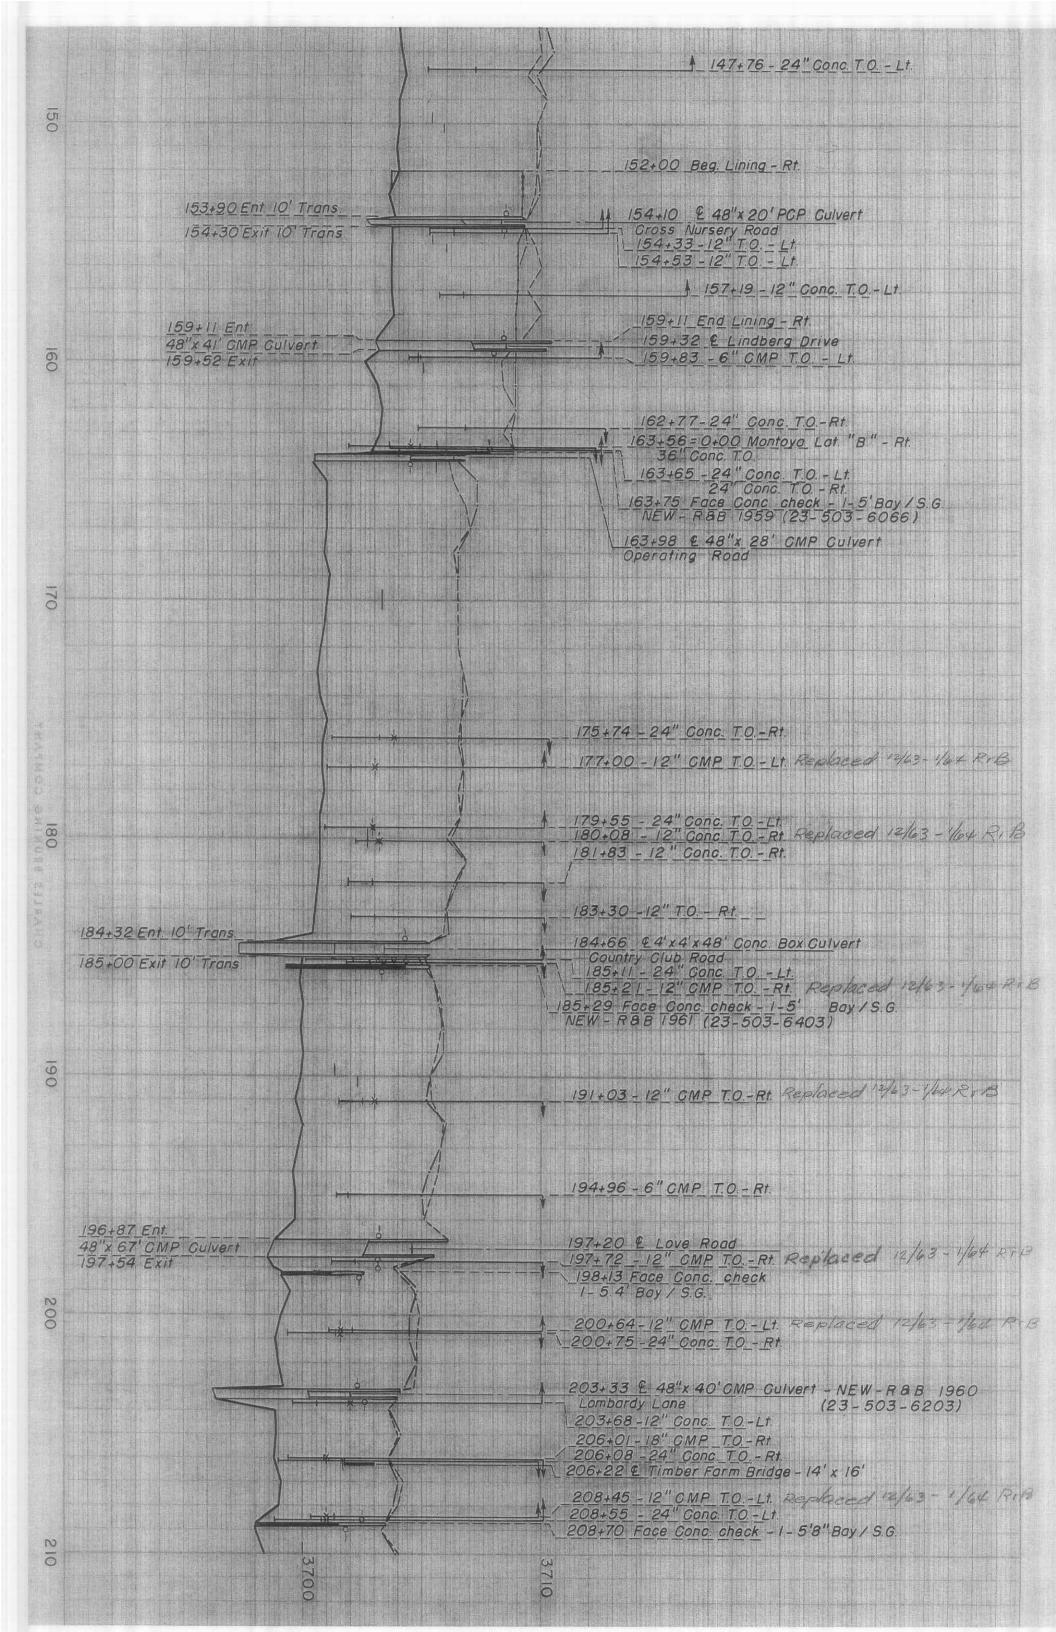
Surveyed: Redman - Nov. 1959 - April 1962 Field Books: File 14M, Book 1959-1 File 12P, Books 1961-0,-D, 8-E
