## Y-147 LATERAL

CONDITION PROFILE 1960

23-503-6267

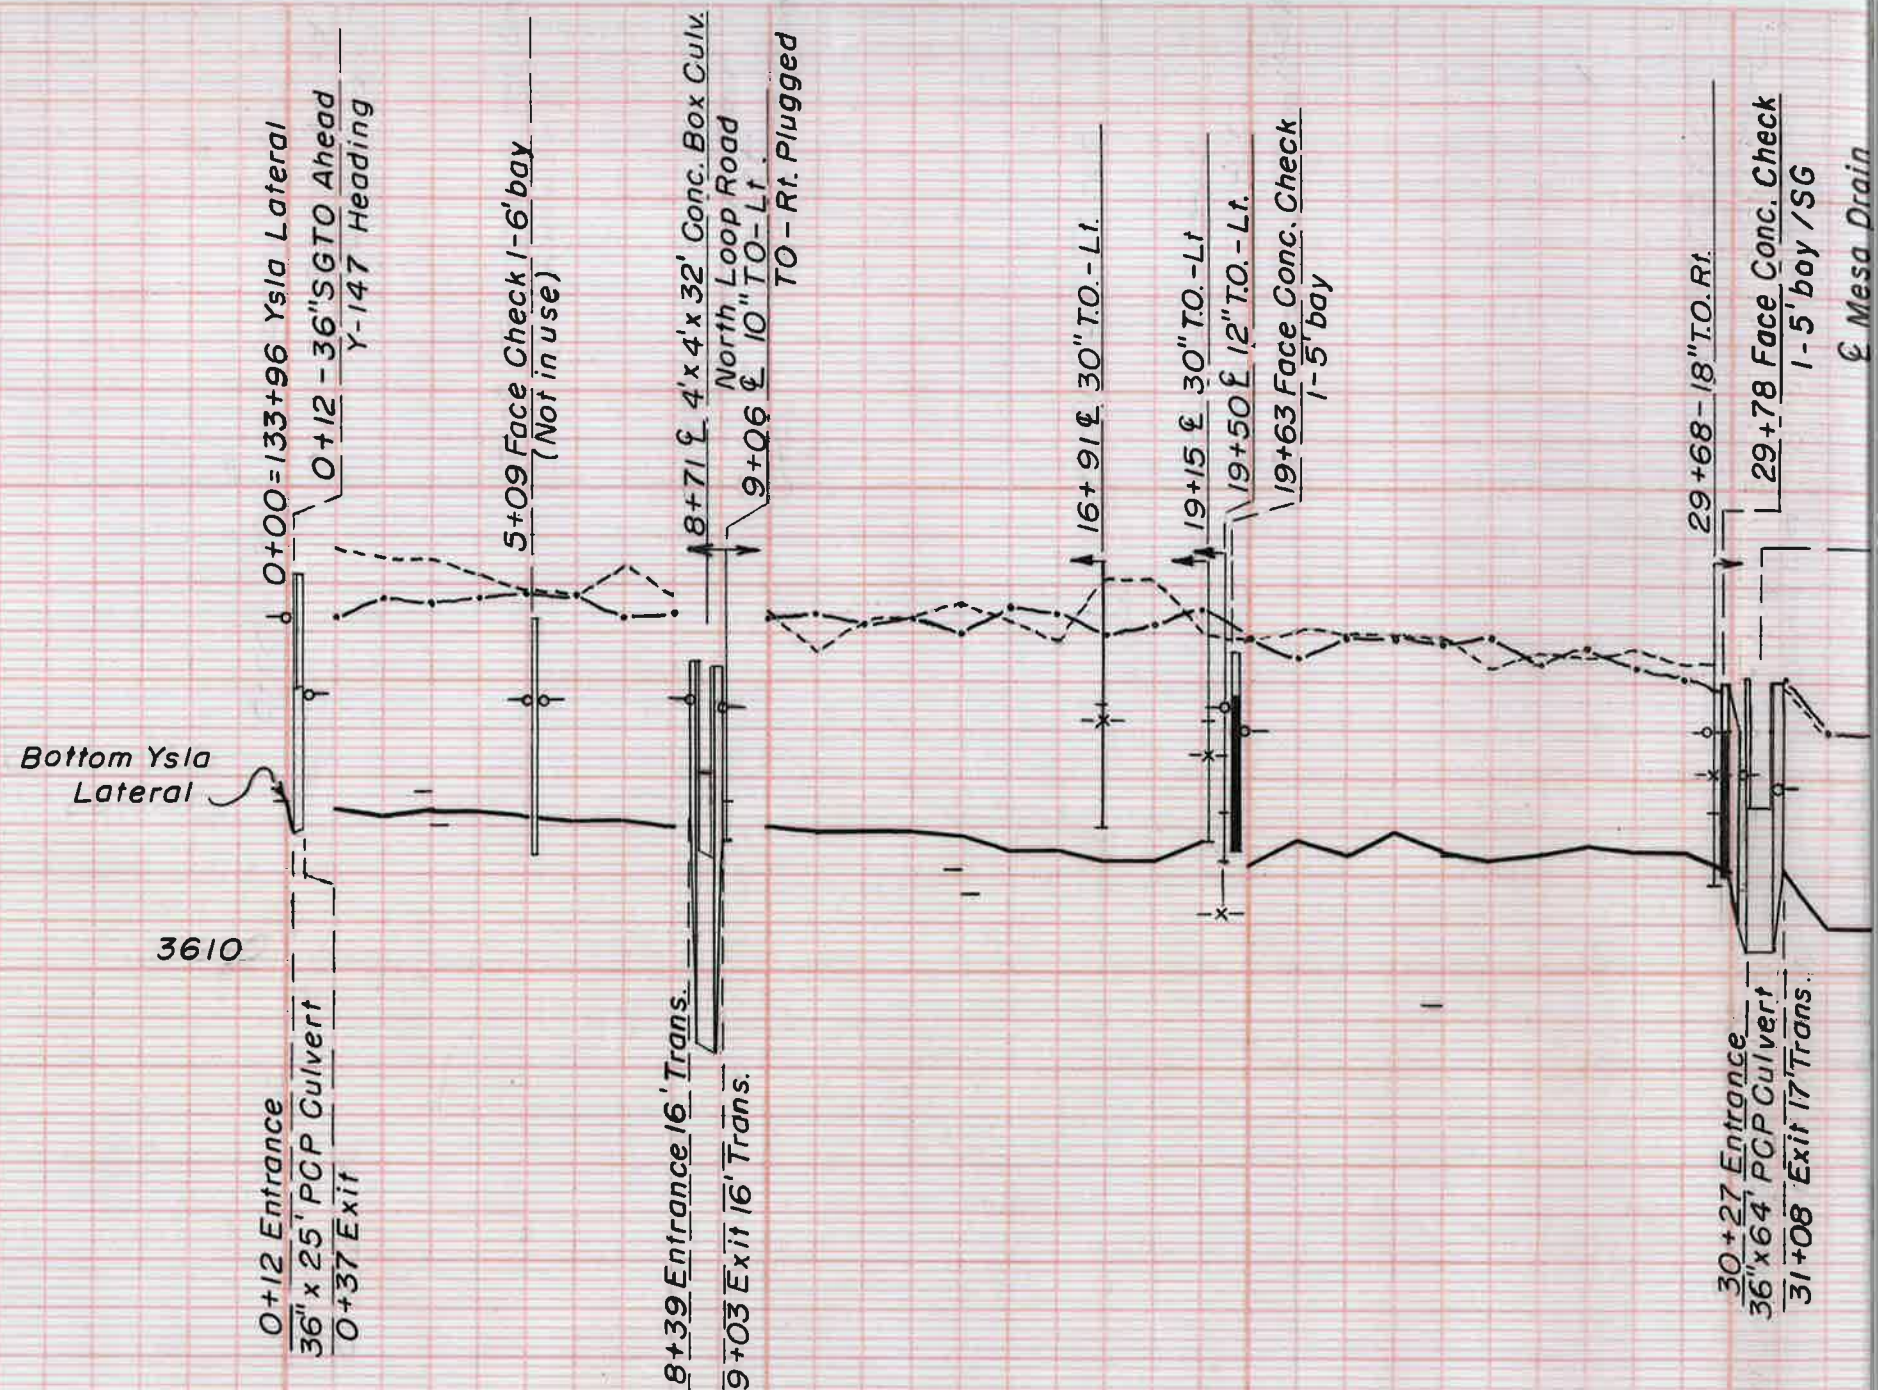
Surveyed by: Oct. 1960  
Notes in field book 3155 Ysleta  
Plotted by: ERJ Feb. 24, 1961  
Inked by: ERJ Mar. 6, 1961  
Checked by: J. B. H.  
Revised 2-20-63 S.A.B.  
to show new structure.
