B.M. Elev. 3623.11 Top concrete headwall downstream corner culvert inlet. North Loop Road Sta. 12+43 Mesa Drain.

STATES  
 INTERIOR  
 AMATION  
 W MEXICO-TEXAS  
**RAIN**  
 159+25  
 FILE 1959  
 59. by Al. Hulbert  
 1-34.  
**23-503-6001**

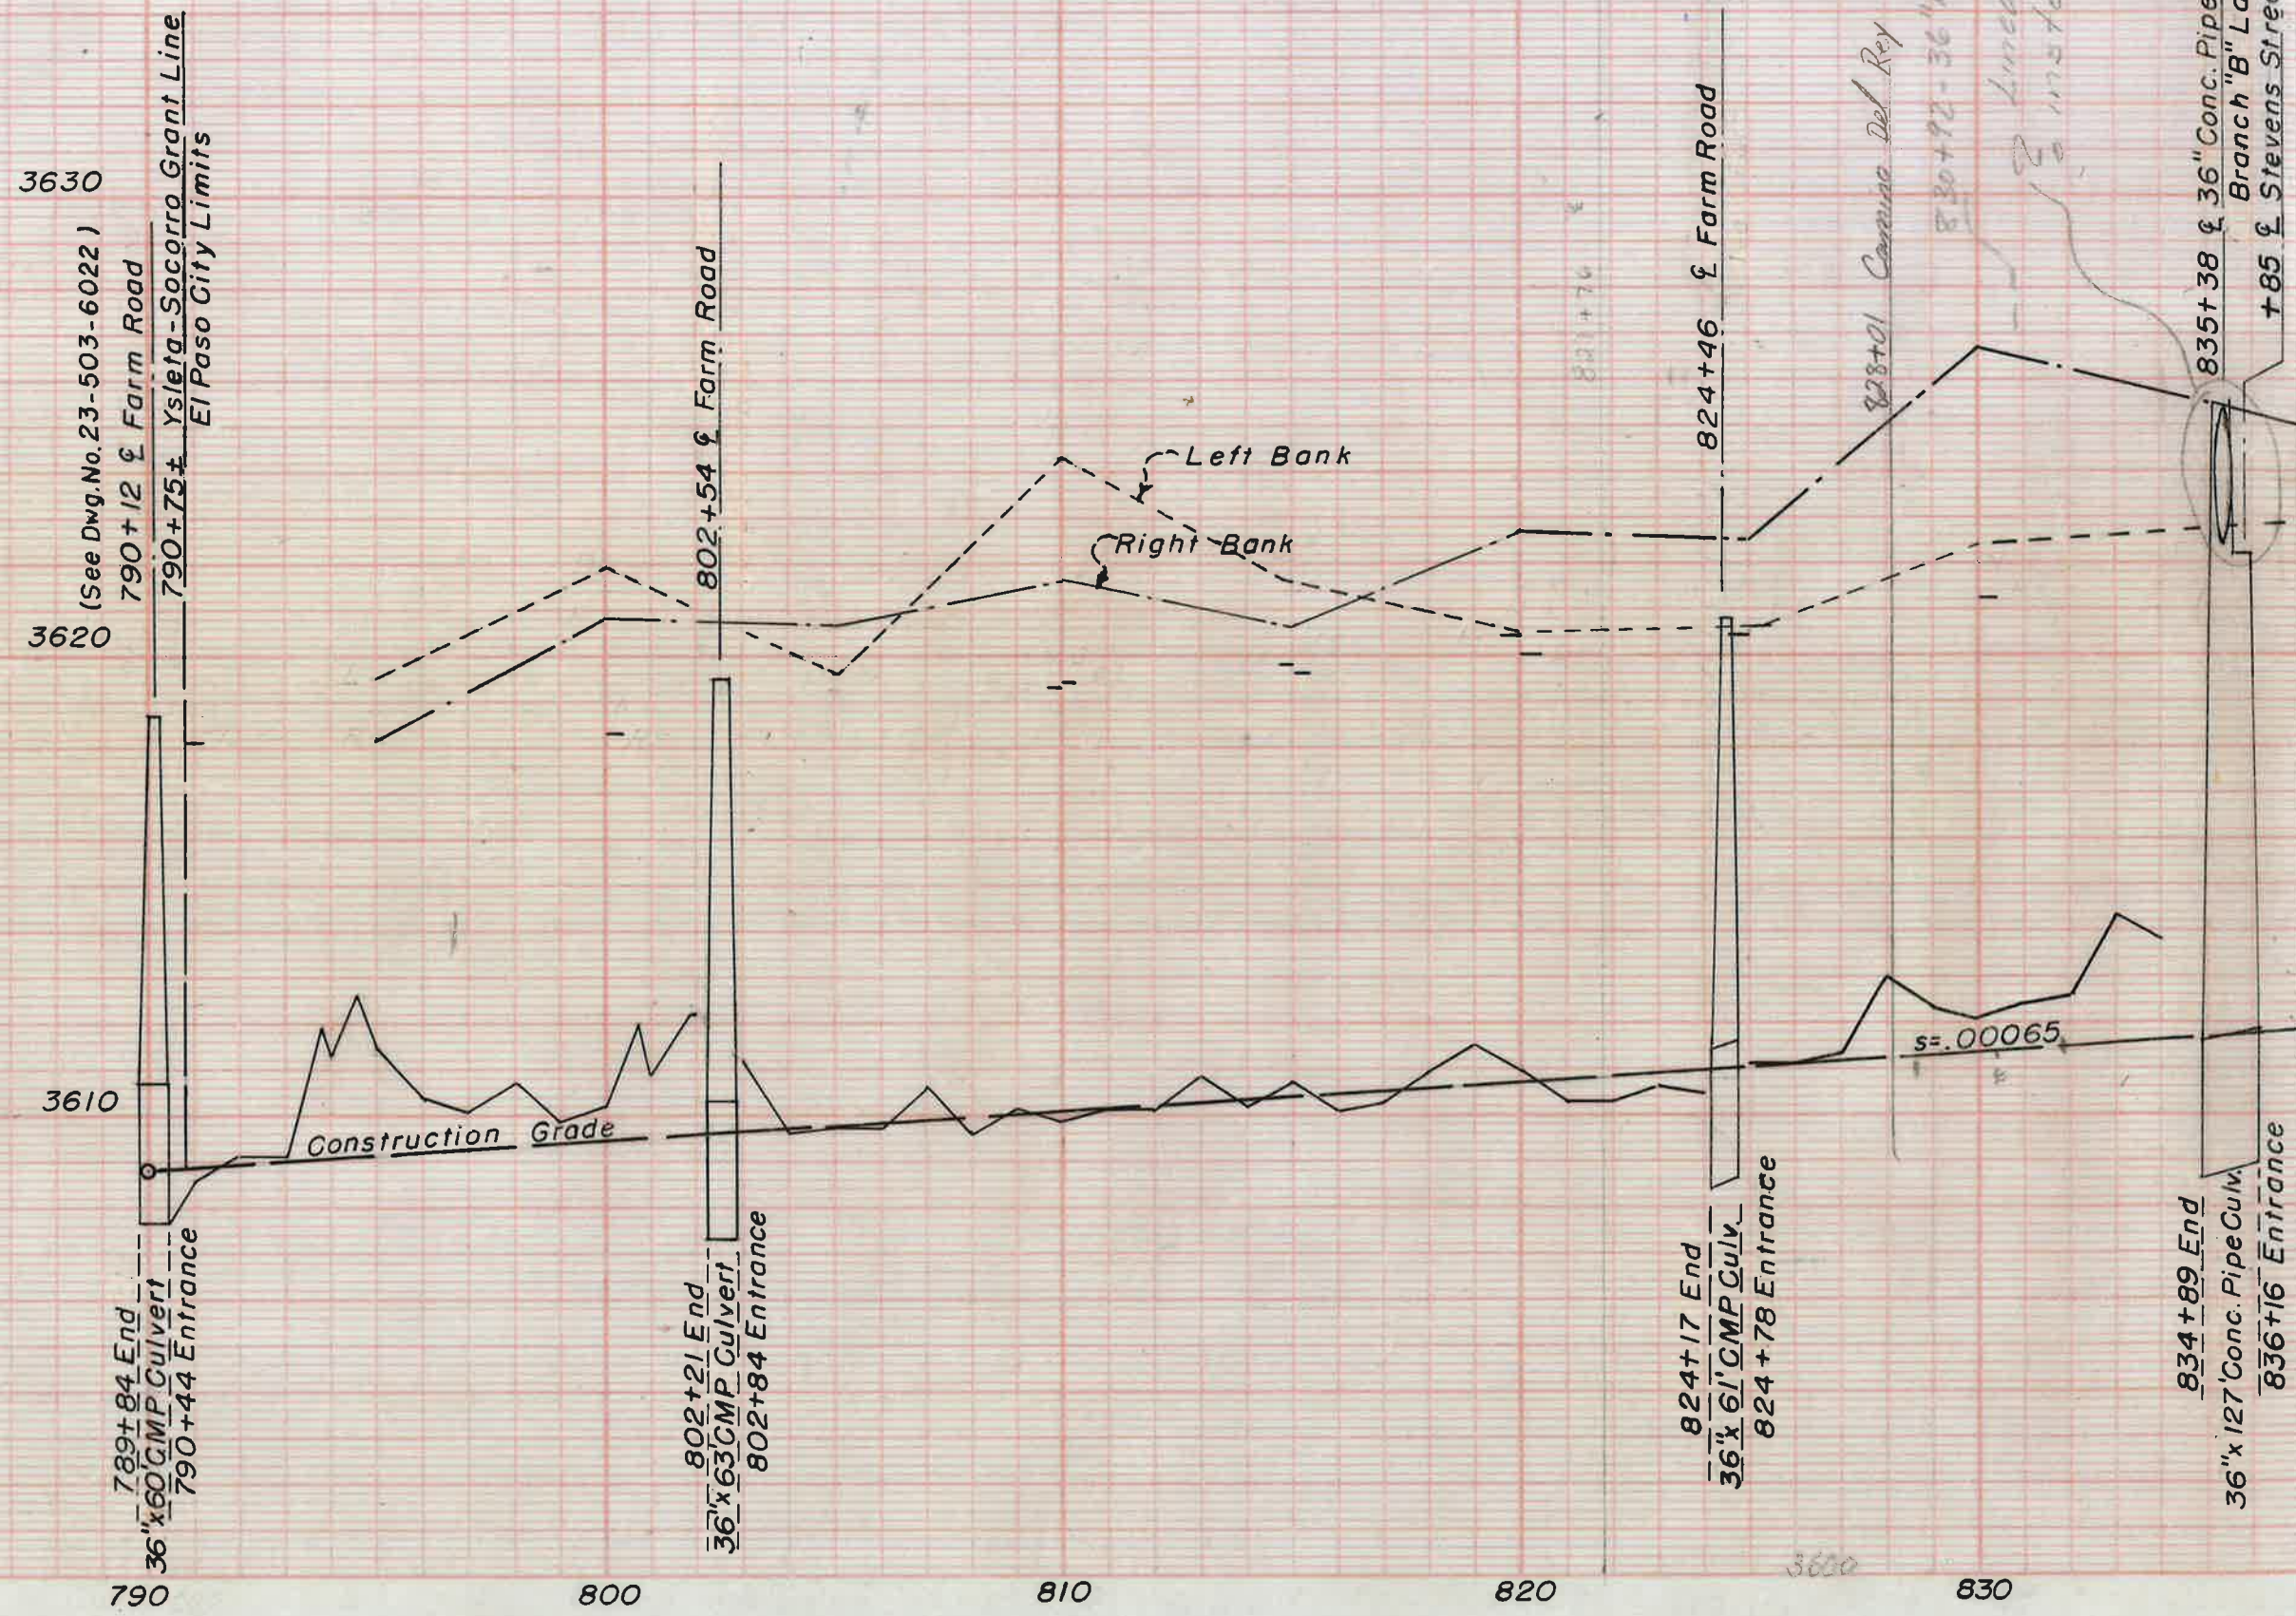
- Left Bank
- Right Bank
- - - - - Natural Surface-Left.
- - - - - Natural Surface-Right.
- ~~~~~ Bottom of Drain
- Construction Grade
