UNITED STATES  
DEPARTMENT OF THE INTERIOR  
BUREAU OF RECLAMATION  
RIO GRANDE PROJECT-NEW MEXICO-TEXAS

**MIDDLE DRAIN  
CONDITION PROFILE  
1960**

SURVEYED BY SMITH-HULBERT, NOV., DEC., 1959-FEB., 1960.  
Notes in Field Books 3099, 3100, 3101 & 3102 Ysleta.  
Plotted Feb., 1960. E.R.J.  
Checked by R.C.

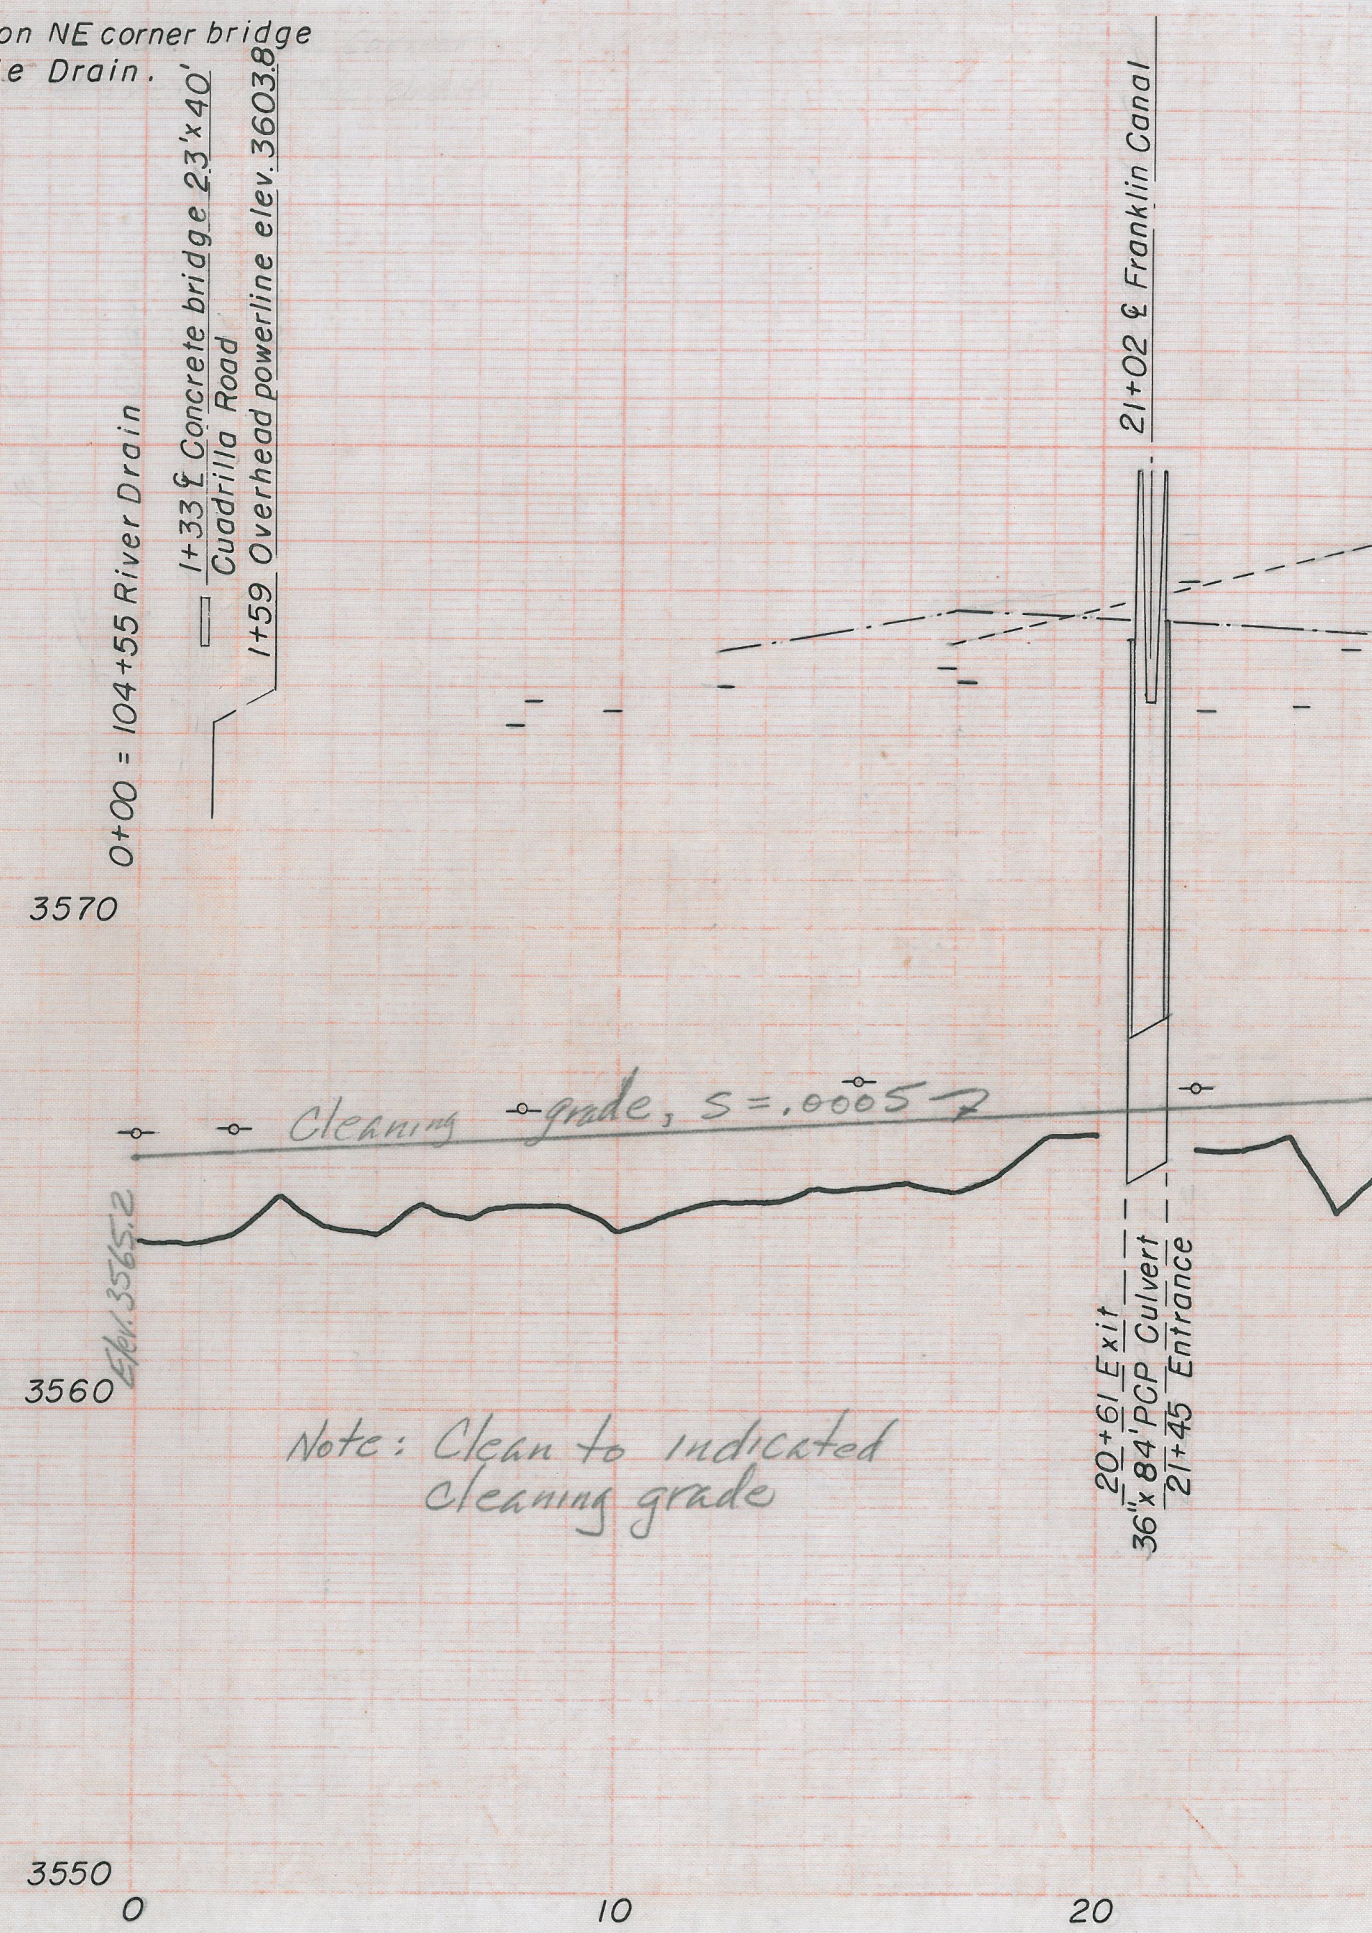
23-503-6096.

B. M. Elev. 3578.17 ☐ Cut in top of concrete rail on NE corner bridge on Cuadrilla Road over Middle Drain.
