VINTON DRAIN  
AND  
PRICE SPUR DRAIN  
1958 CONDITION PROFILE

Field Book 18H-1958-3  
Surveyed Sept., 29, 1958.  
Plotted & inked by E. R. J.  
Checked by R. S.

23-503-5968.

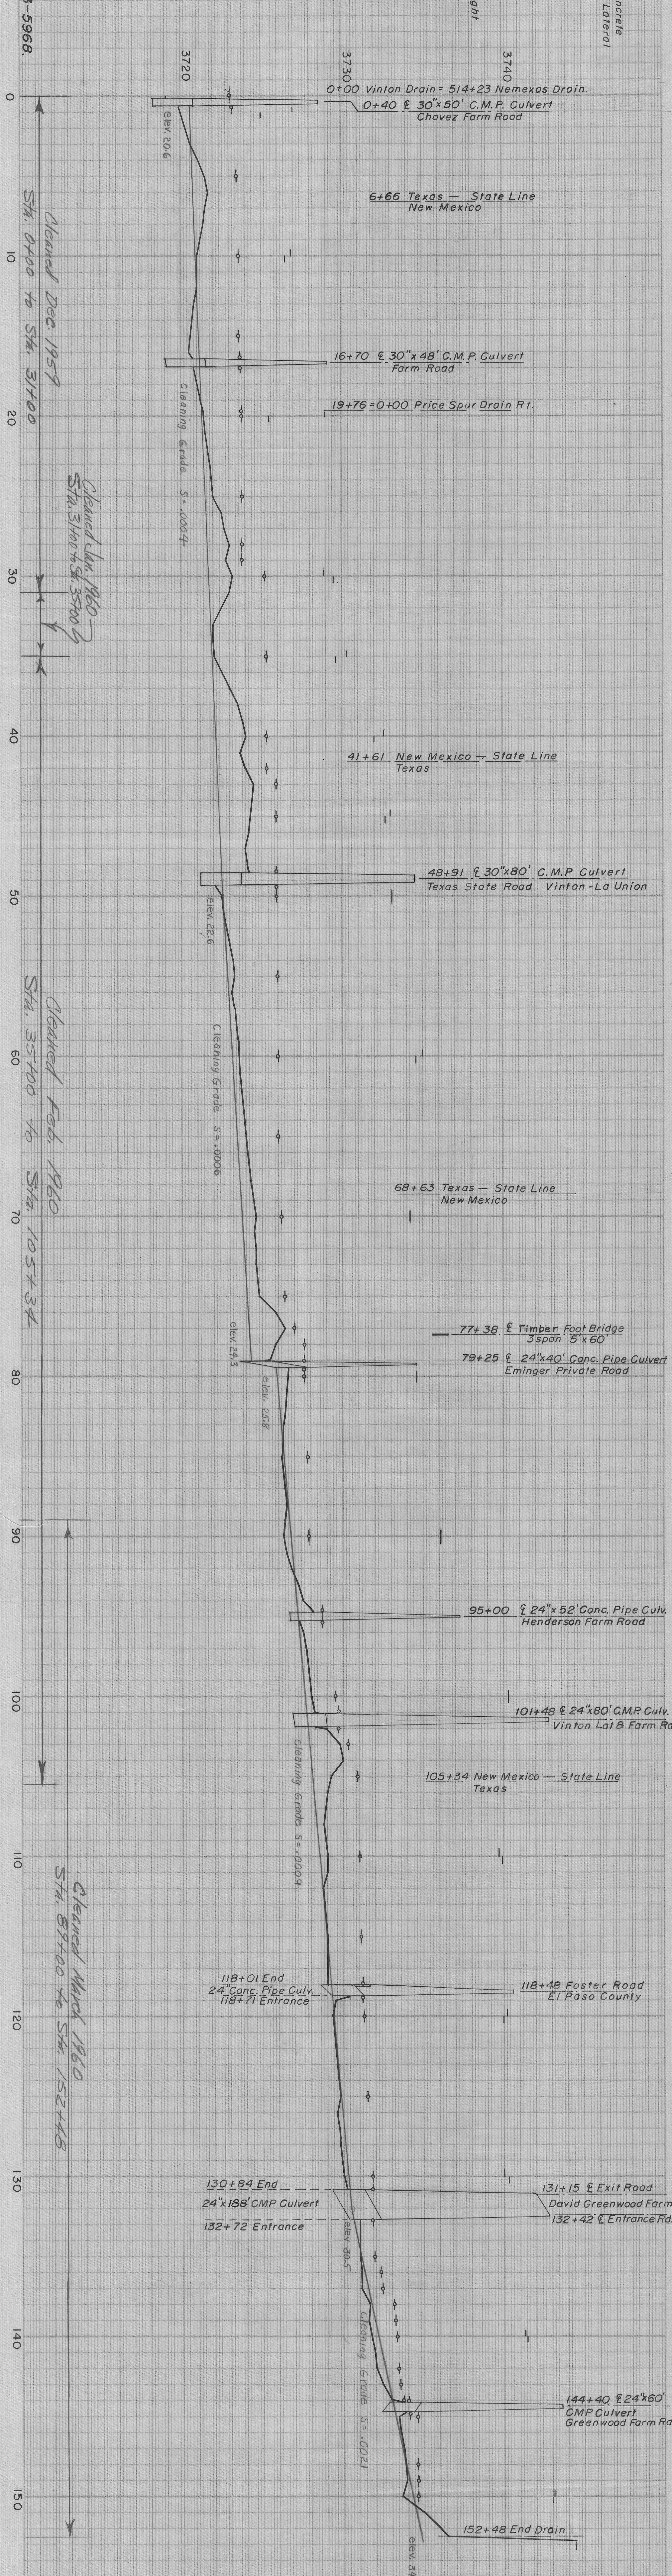
B. M. Elev. 3732.98 North end concrete headwall at entrance of Mondell Lateral culvert over Nemexas Drain.

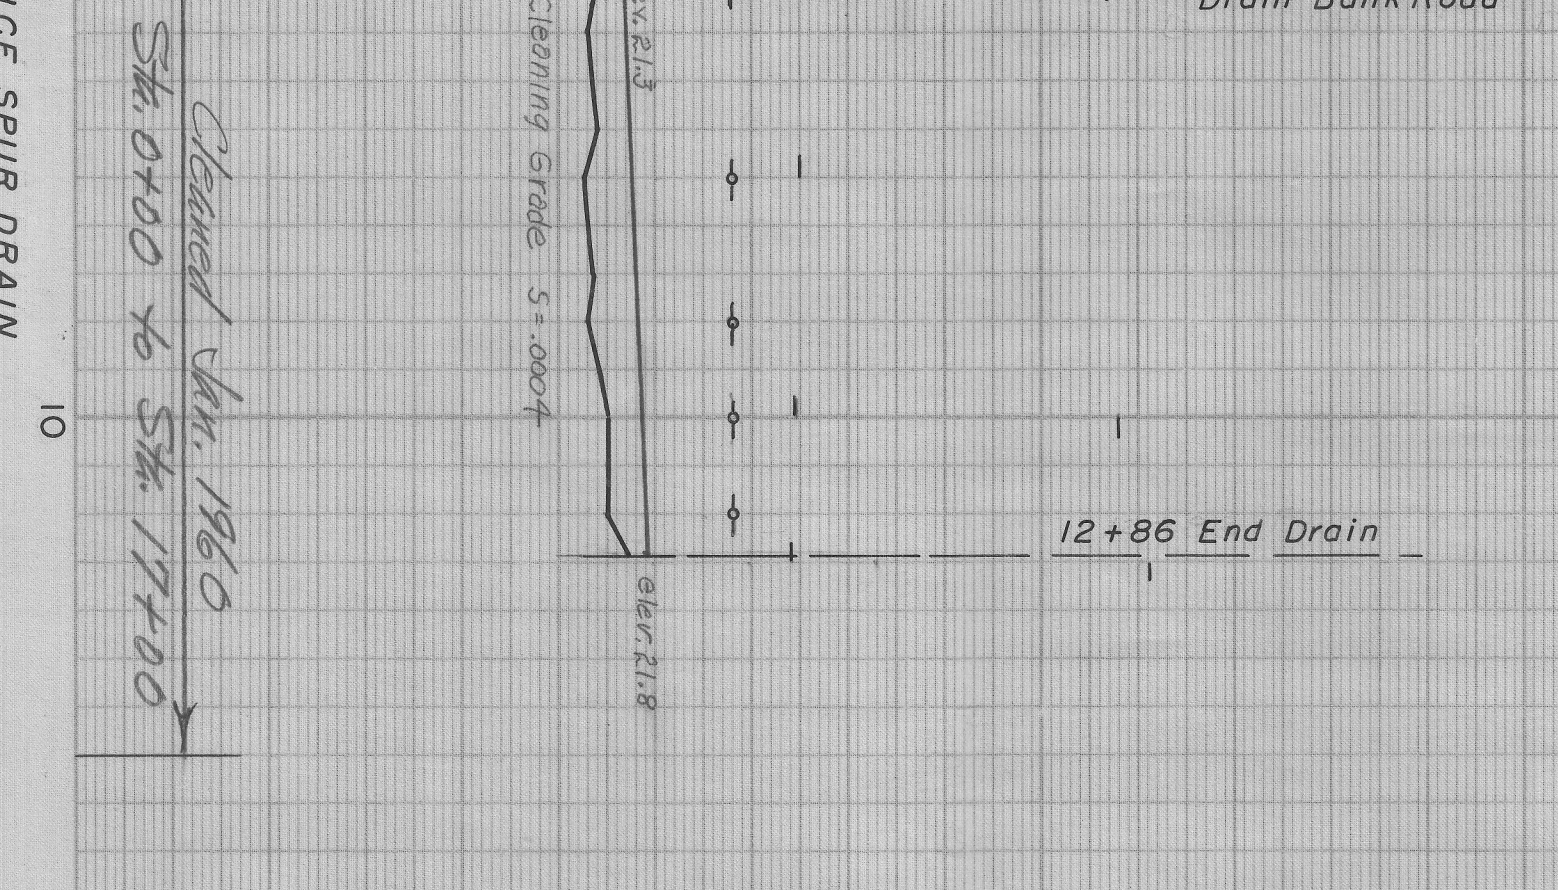
23-503-5968.

B. M. Elev. 3746.40 On East concrete pier Rowley Lateral check Sta. 39+52

B. M. Elev. 3725.92 On South end concrete block at end drain.

VINTON DRAIN  
AND  
PRICE SPUR DRAIN  
1958 CONDITION PROFILE
