CAÑAS AGRÍAS LATERAL  
CONDITION PROFILE 1960

23-503-6620

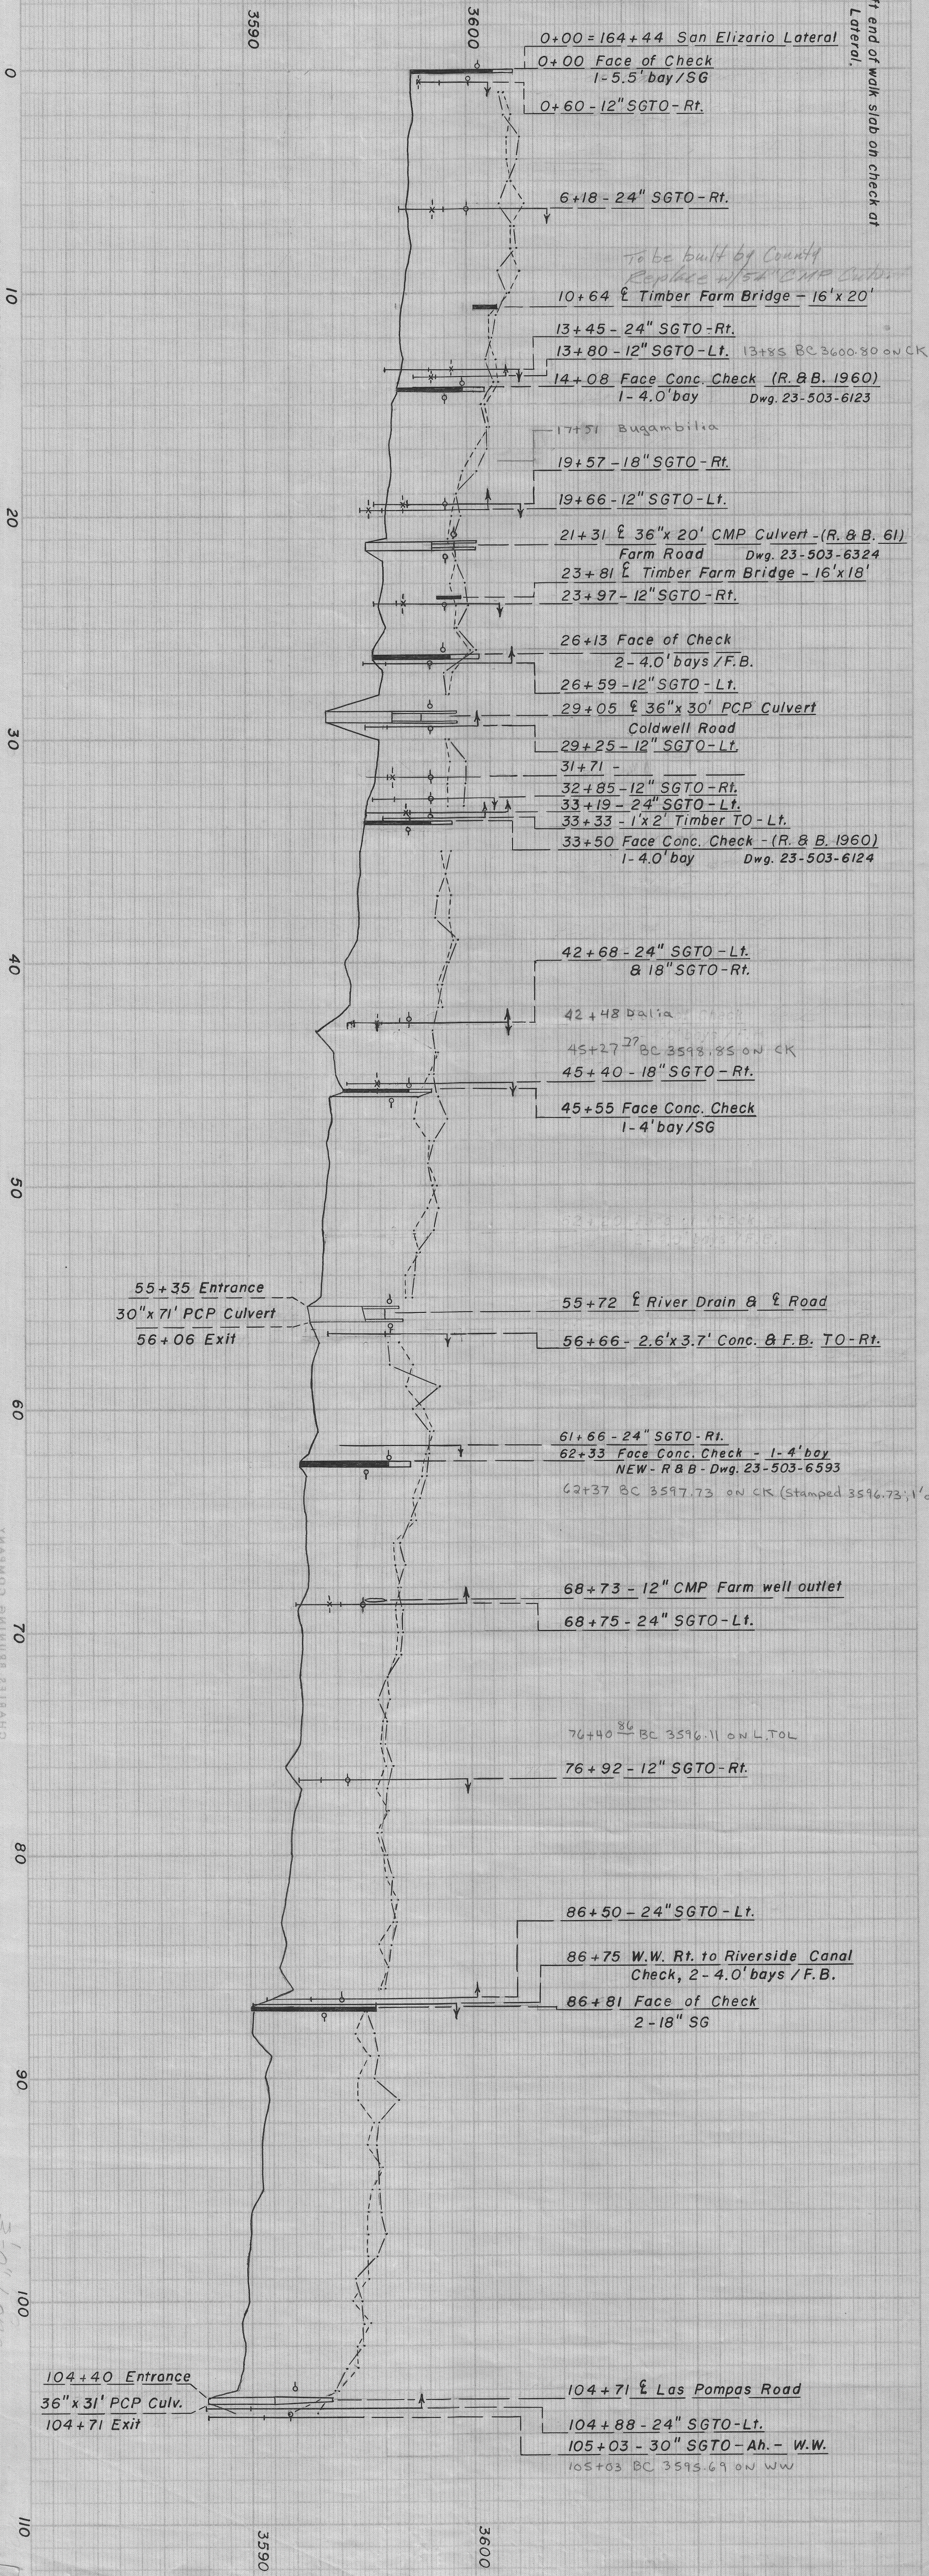
Surveyed by Smith 5/20/60  
Notes in field book 3127 Ysleta  
Plotted by SAB 5/11/62  
Inked by SAB 5/2/62  
Checked by *[Signature]*  
Revised 2-27-63 SAB  
to show K&B Structures.
