**MONTOKA LATERAL "A"**  
CONDITION PROFILE 1962

Surveyed by Redman 5-2-62  
Field Book No. 13-P, File 1961-H, Las Cruces  
Plotted by S.A.B.  
Checked by R.G.

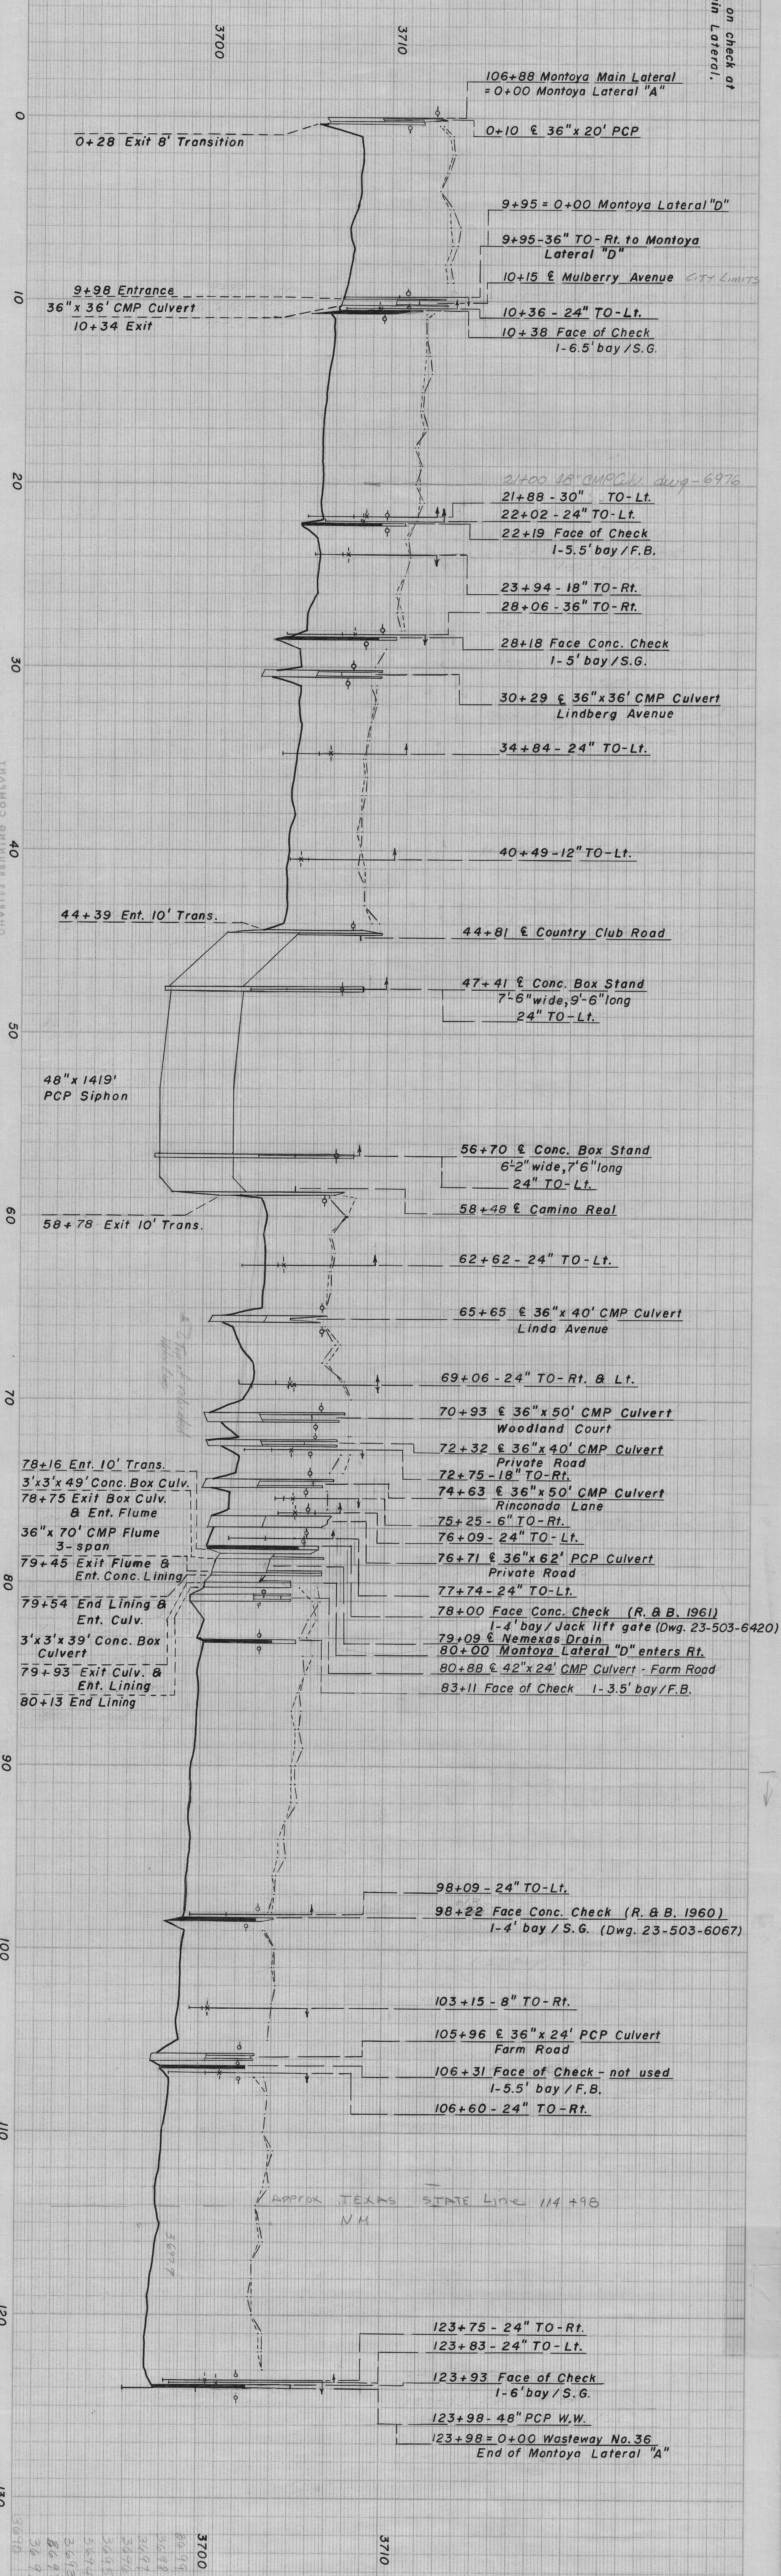
23-503-6634

LEGEND  
Right bank  
Left bank  
High Water Surface  
High Water, end of turnout  
Natural Surface, left and right  
Bottom of lateral
