**PENCE LATERAL**  
CONDITION PROFILE 1961

Surveyed by Redman Aug. 7, 1961.

23-503-6385.

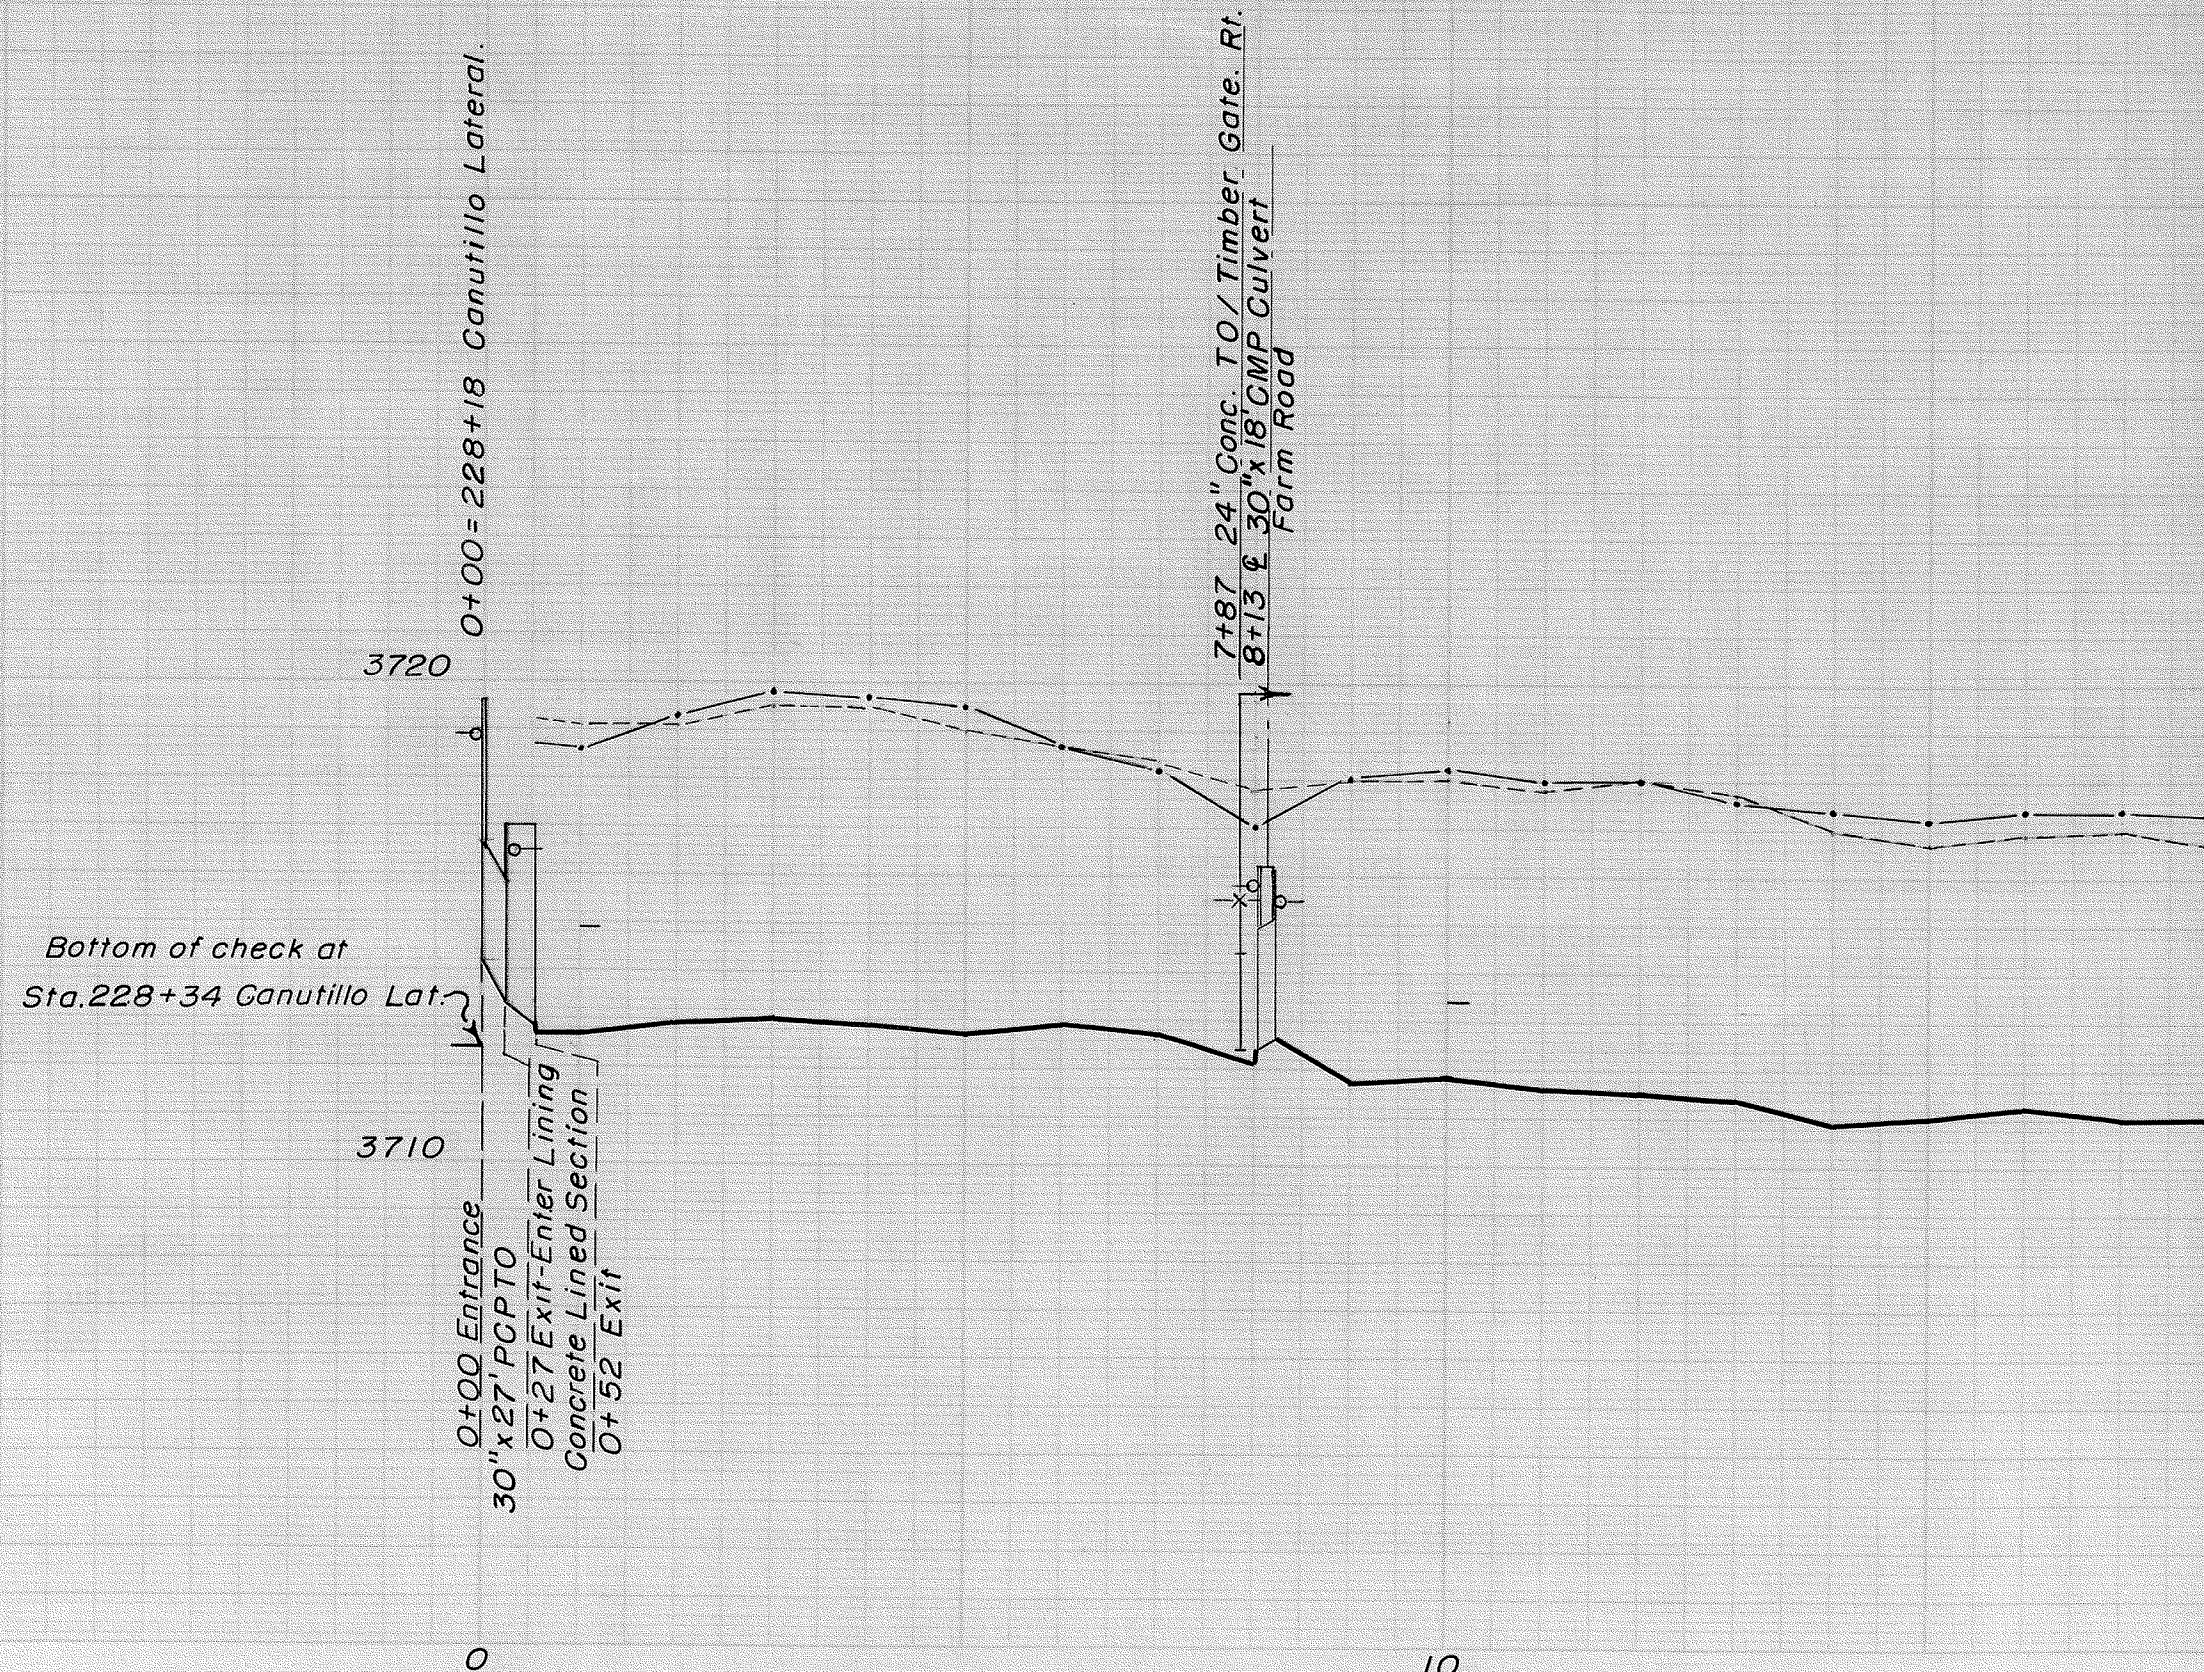
0+52 Exit

7+87 24" Conc. TO / Timber Gate Rt.  
8+13 30" x 18" CMP Culvert  
Farm Road

30+69 - 24" Conc. TO / Timber Gate Rt.  
31+11 Pence Lat. = 0+00 W.W. #34A

30+73 Entrance  
Concrete Lined Section  
31+11 Exit. Ent. 4 Trans.  
F B Control

30" PCP Culvert  
W. W. No. 34 A
