TEXAS LATERAL  
CONDITION PROFILE 1963

Surveyed by Breiten Apr. 19, 1963  
Notes in F.B. 12 File A 1963-64 Las Cruces  
Plotted by ERJ June 4, 1963.  
Checked by R.C.

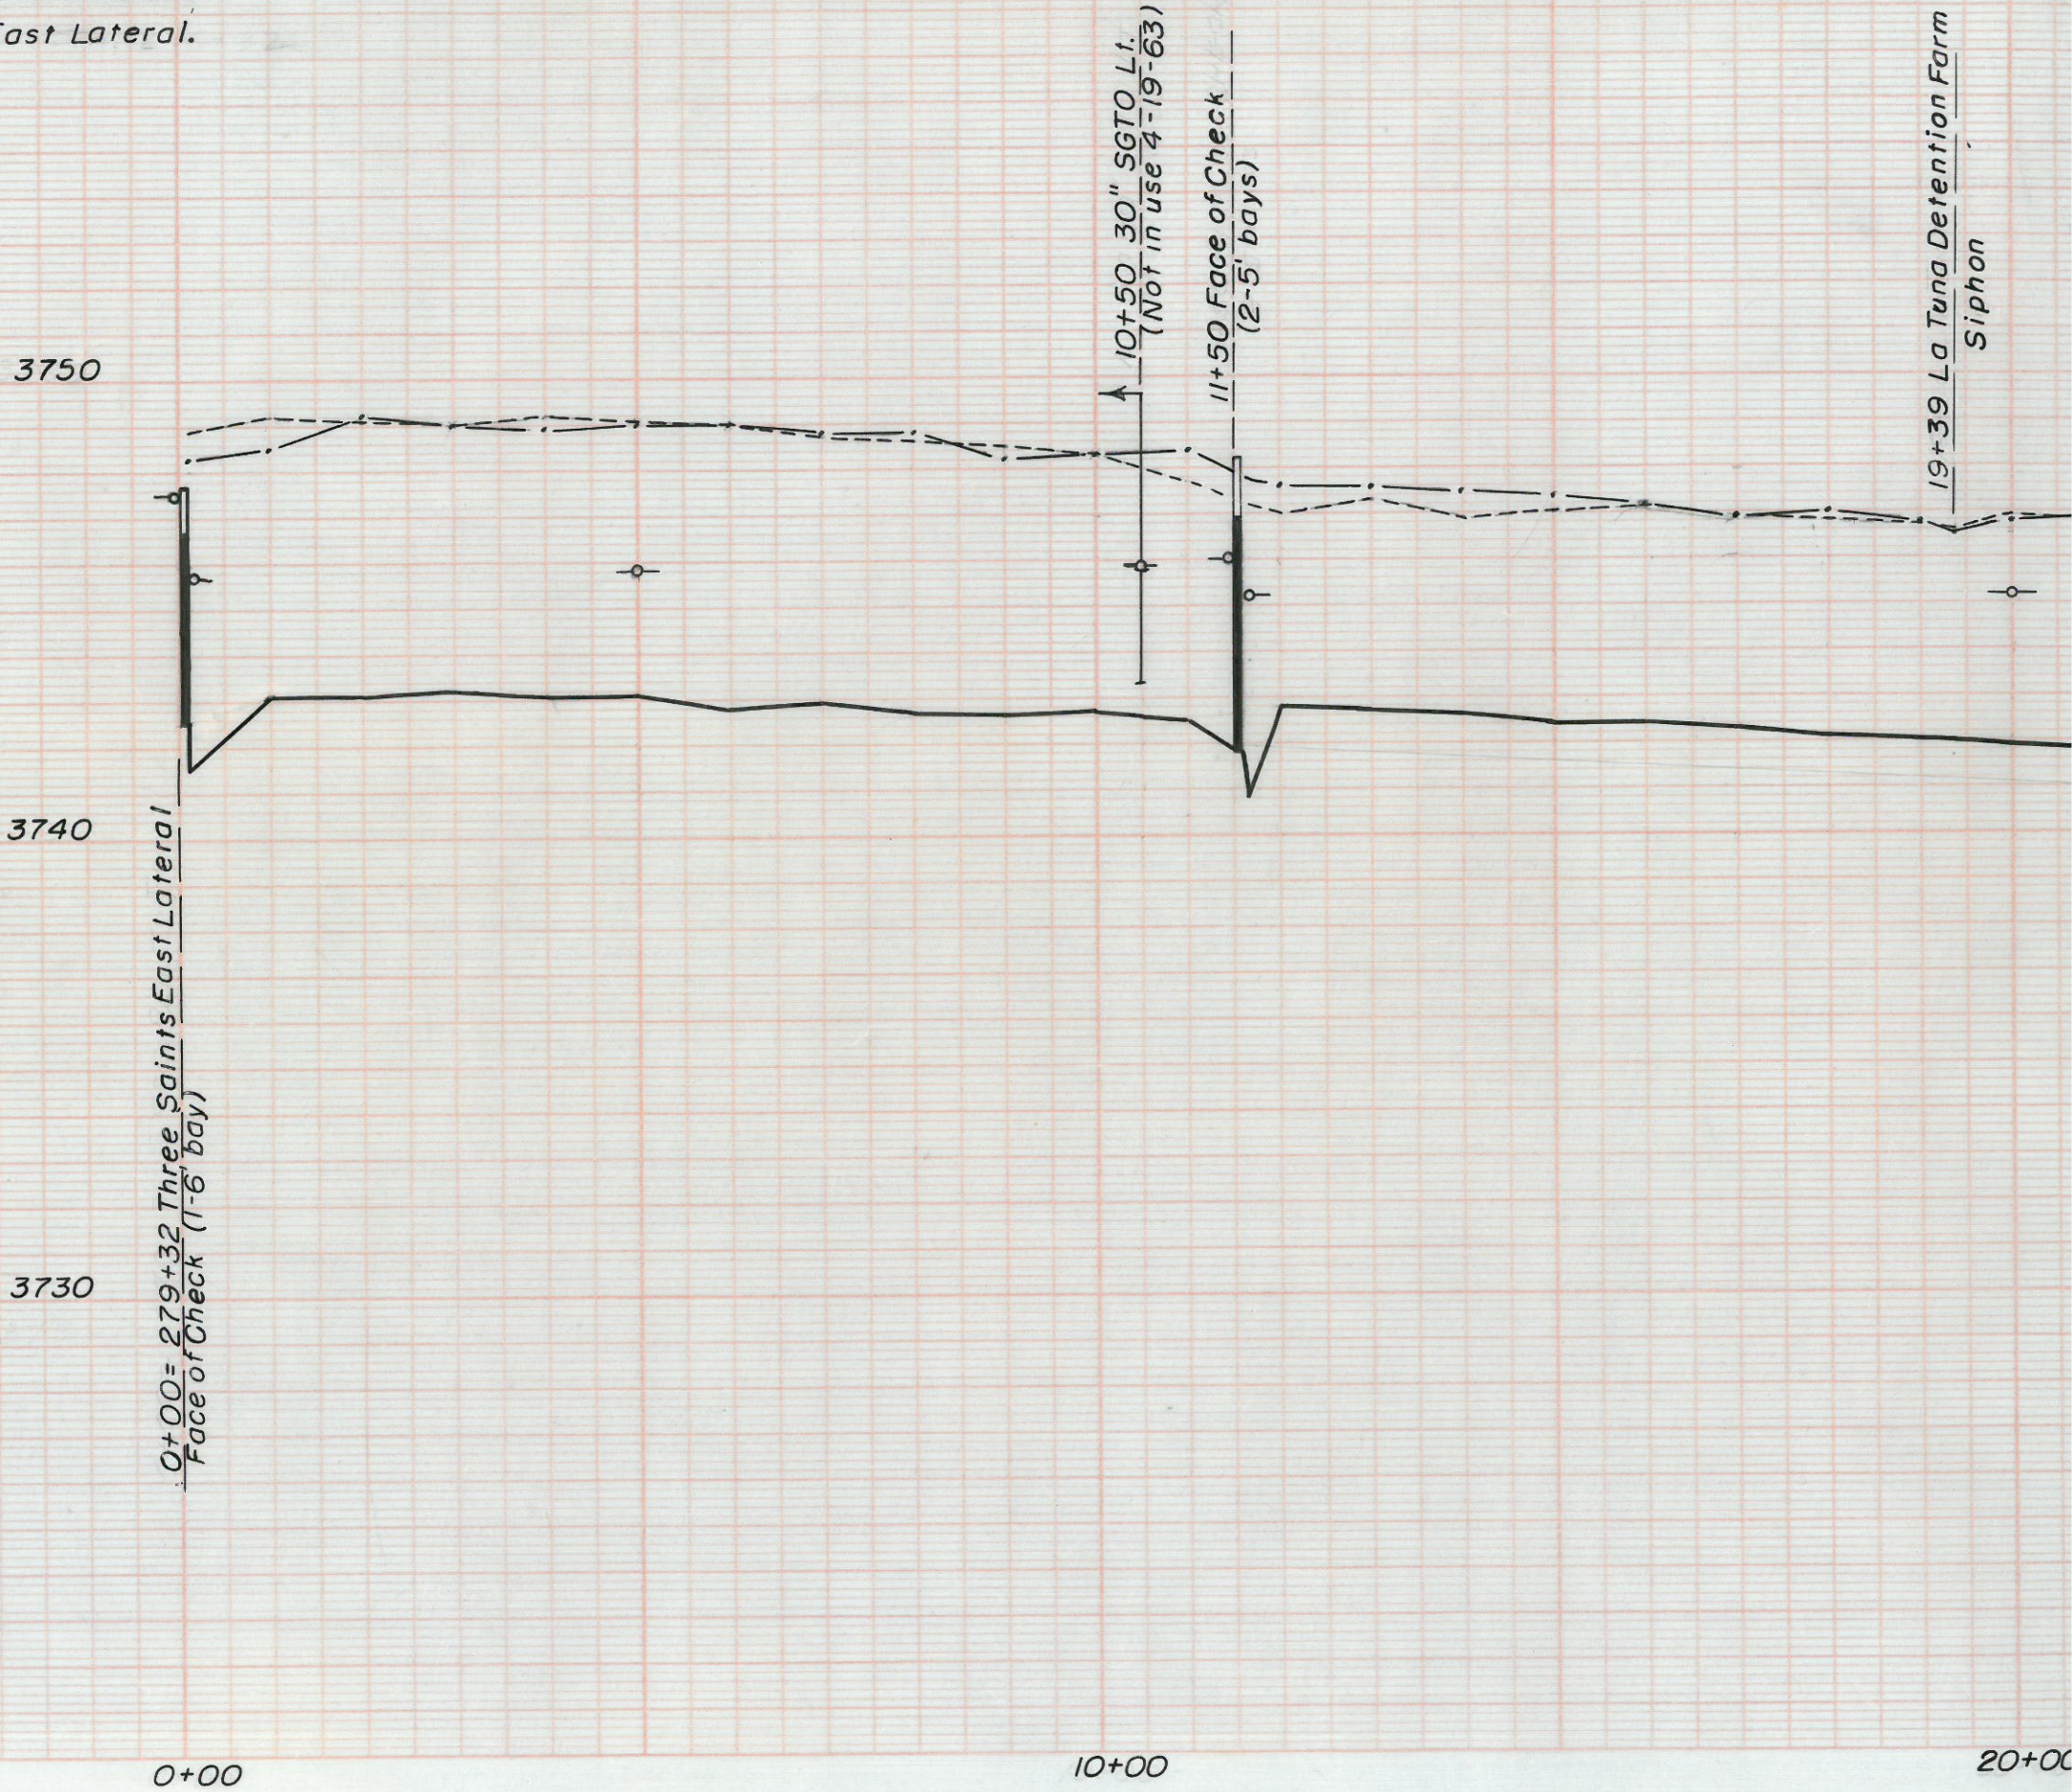
23-503-6970

B.M. Elev. 3747.69 "□" Painted on left side of check face of Texas Lateral heading and equal to Sta. 279+32 of the Three Saints East Lateral.
